# Building Inspection Report

123 Sample Street Sample Town, NJ 12345

04/04/2022

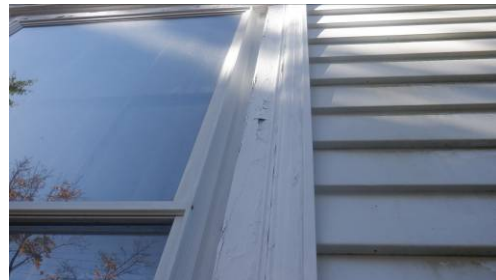
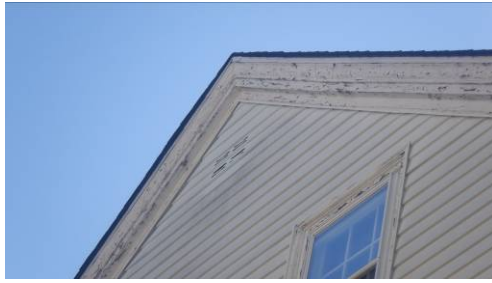
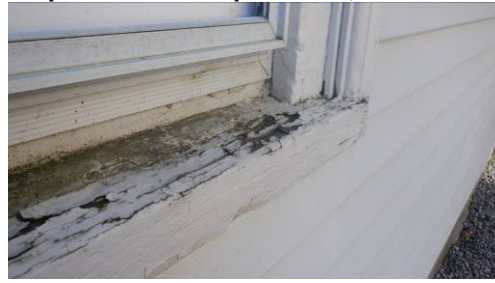
- **Action required:** There was a significant amount of wood rot noted to the window trim and sills around the structure. Repairs are necessary at this time to prevent further deterioration and possible moisture intrusion. There may be areas of hidden damage not visible due to the non-invasive nature of this inspection. Consideration should be given to wrapping exposed exterior wood with aluminum to reduce maintenance. Contact a qualified contractor to make a further evaluation and the necessary repairs.

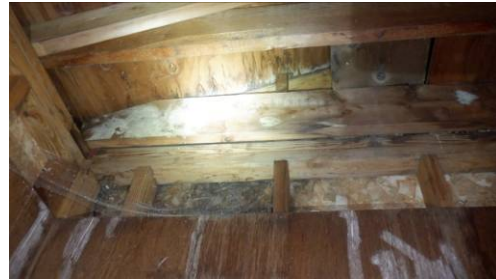
- **Action required:** There are indications the roof system is currently leaking. Current leaking was discovered in the back left corner of the garage. The area tested wet at the time of the inspection. Repairs are necessary. Contacting a qualified roofing contractor for full evaluation and repairs is necessary.

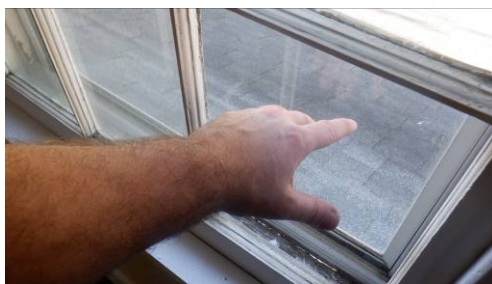
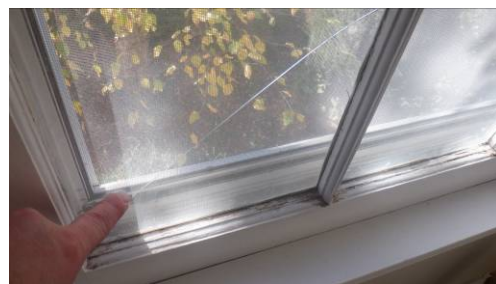
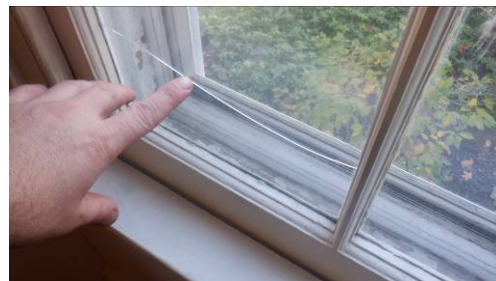
- **Action required:** There is loose broken/missing glass at several of the windows that could result in an injury. Repairs are necessary for safety.

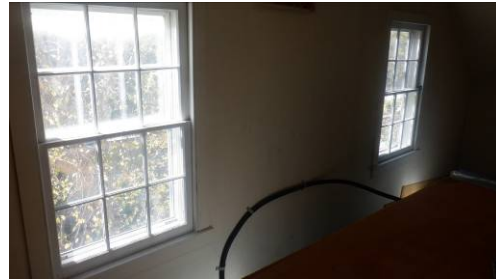
- **Action required:** A random test of the windows was done to see if they could be latched/locked and opened/closed. The test revealed that the majority of the older windows in the structure have broken balances. The windows will not stay in the desired position without a prop. Repairs are necessary as windows with broken balances are a potential safety hazard and eliminate an egress in the event of a fire.

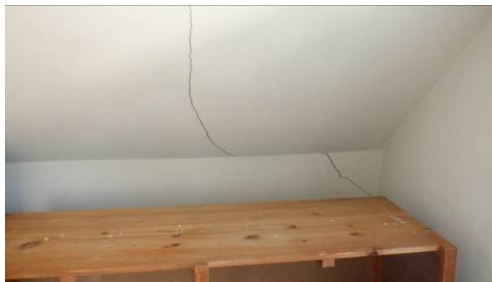
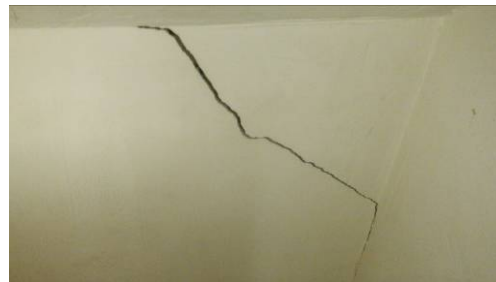
- **Action required:** Some of the upper plaster walls/ceilings were damaged and in need of repair to prevent further cracking and damage. There was significant cracking in the upper right rear plaster walls. This may be an indication of structural defects. Contact a licensed structural engineer to make a further evaluation and any necessary repairs to ensure proper structural support.

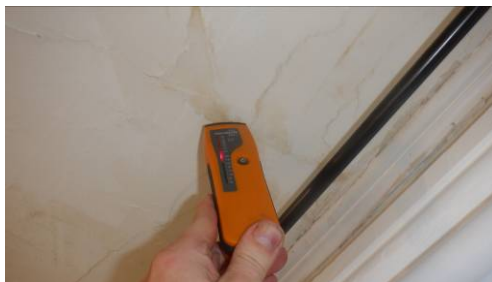
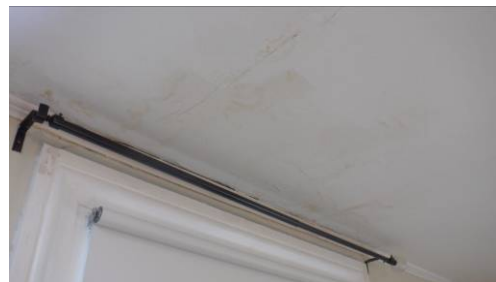
- **Action required:** Current moisture intrusion was noted on the master bathroom ceiling above the front window. This may be due to rotted trim of poor/failing flashing around the dormer. A further evaluation by a qualified contractor is recommended.

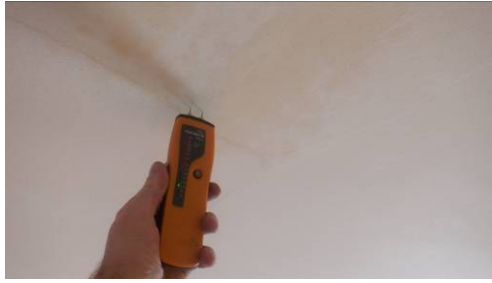
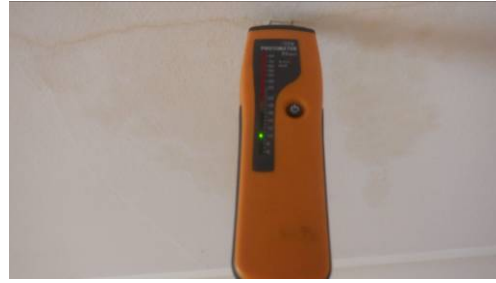
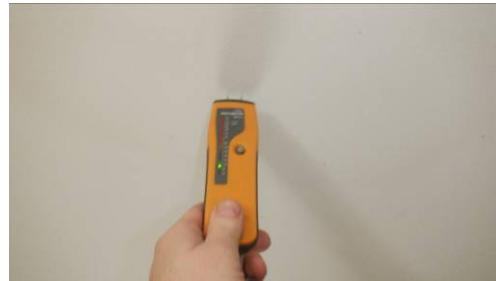
- **Action required:** There were moisture stains evident on the living room ceiling, kitchen ceiling, and rear lower close ceiling that tested dry at the time of the inspection. The exact origins could not be confirmed. A further evaluation by a qualified contractor is recommended.

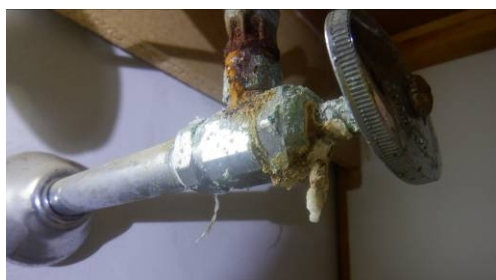
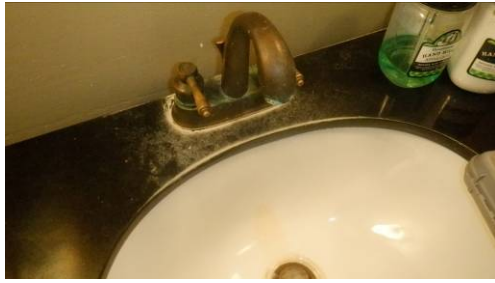
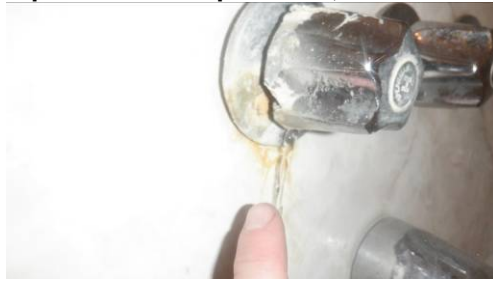
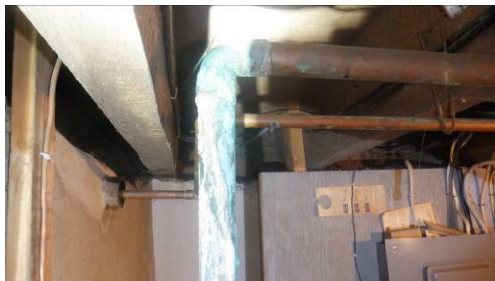
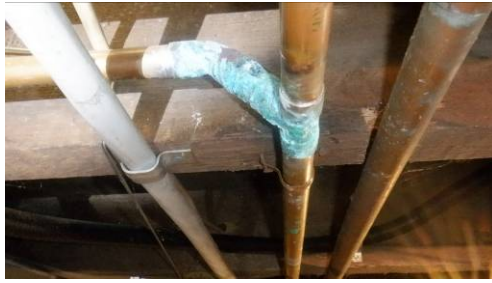
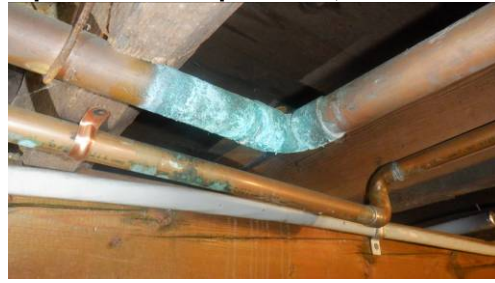
- **Action required:** An inspection of the readily accessible sections of the plumbing water supply, waste pipes, faucets and fixtures identified visible leak (s) that require repair at this time. The water was left running for approximately 10 minutes and the toilets were flushed at least 4 times at the time of the inspection. The inspector discovered current leaking at the right side master bathroom sink drain connection, right side master bathroom sink supply connection, the lower bathroom shower diverters, the lower bathroom sink drain connection, the kitchen sink diverter supply connections, The wet bar supply connections, the main copper supply connections in the basement, and several copper supply lines in the basement. In addition, the lower bathroom sink was dripping continuously in the OFF position. Repairs are recommended to prevent further deterioration and subsequent damage. Contact a licensed plumber to make a FULL technically exhaustive evaluation and the necessary repairs prior to transfer of ownership.

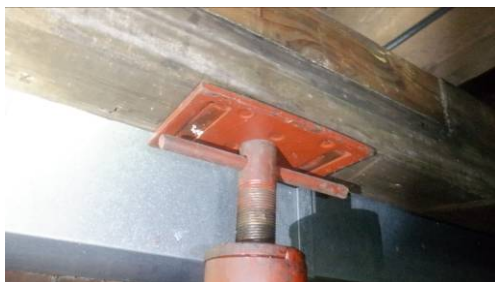
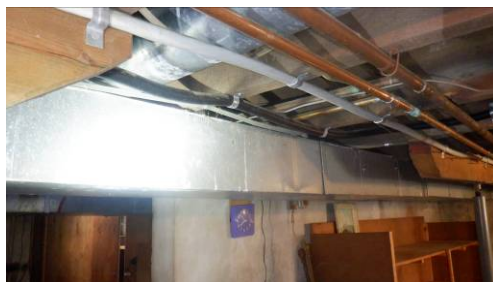
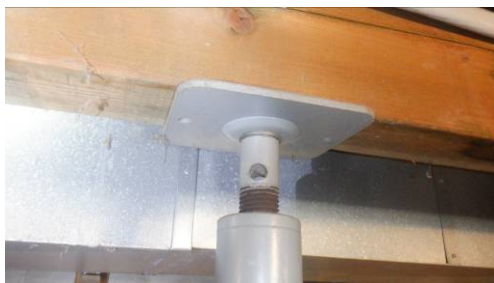
- **Action required:** There have been several temporary screw jack columns added in the basement that are not on any footings and are sitting on top of the floor slab, which is not designed to hold the weight. Footings are necessary to properly support the weight from above. In addition, the plates were not properly secured to girders with bolts. Furthermore, these columns are for temporary use not permanent use. It should also be noted that the columns were not properly installing at the end barring which is causing additional sagging. Contact a licensed structural engineer to make a further evaluation and the necessary repairs to ensure proper structural support.

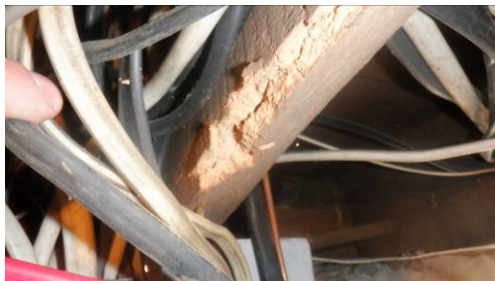
- **Action required:** The inspector discovered excessive powder post beetle and termite damage/activity in the basement. A full wood destroying insect infestation inspection is recommended to determine the need for treatment and/or repair. There may be areas of hidden damage not visible due to the non-invasive nature of this inspection.

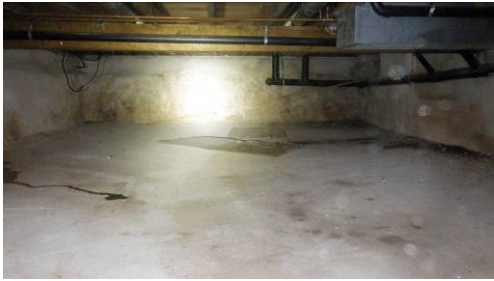
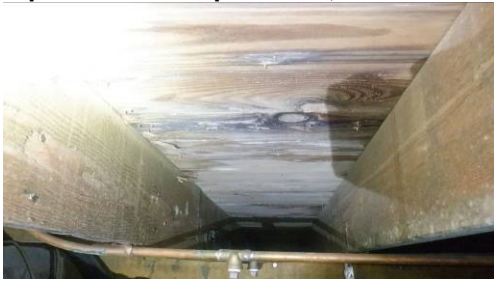
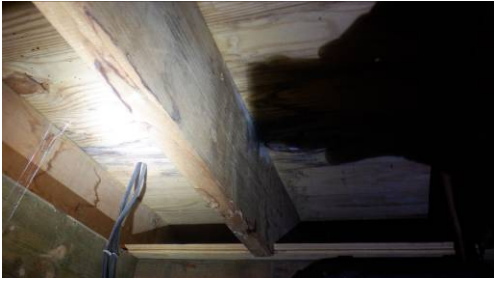
- **Action required:** Crawl spaces should be properly vented to reduce moisture levels. There was currently moisture intrusion and possible development of mold in the crawl space at the time of the inspection. Action should be taken to create better ventilation or dehumidification for the crawl space area to reduce the excessive moisture levels. Cleaning the areas with possible development of mold is also recommended to prevent a possible allergic reaction. A further evaluation by a qualified contractor is recommended prior to transfer of ownership.

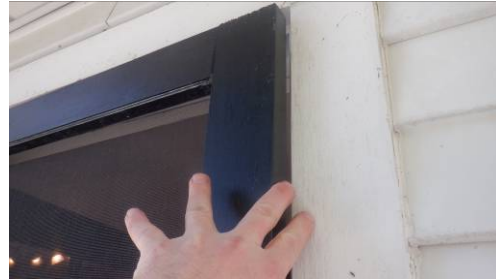
- **Attention:** The exterior storm doors are in need of minor fit adjustments. A further evaluation by qualified contractor is recommended.

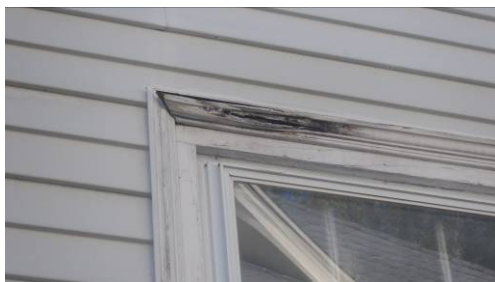
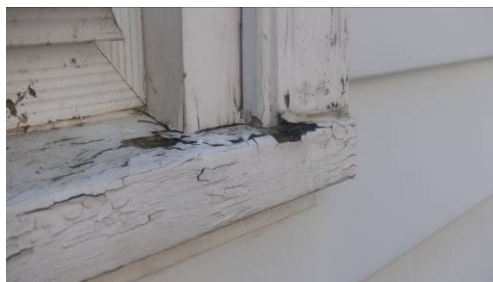
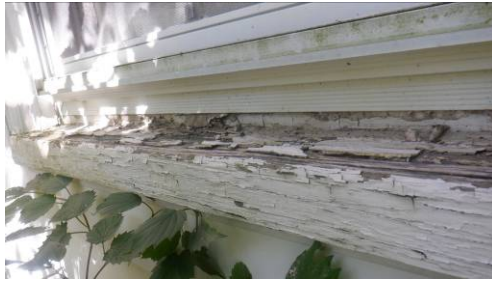
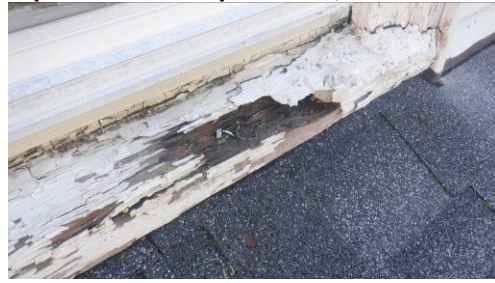
- **Action required:** There was a significant amount of wood rot noted to the window trim and sills around the structure. Repairs are necessary at this time to prevent further deterioration and possible moisture intrusion. There may be areas of hidden damage not visible due to the non-invasive nature of this inspection. Consideration should be given to wrapping exposed exterior wood with aluminum to reduce maintenance. Contact a qualified contractor to make a further evaluation and the necessary repairs.

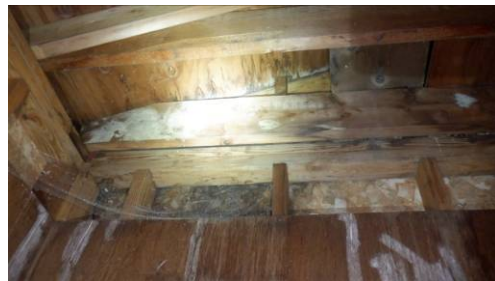
- **Action required:** There are indications the roof system is currently leaking. Current leaking was discovered in the back left corner of the garage. The area tested wet at the time of the inspection. Repairs are necessary. Contacting a qualified roofing contractor for full evaluation and repairs is necessary.

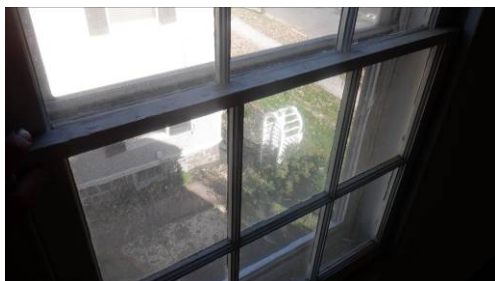
- **Action required:** A random test of the windows was done to see if they could be latched/locked and opened/closed. The test revealed that the majority of the older windows in the structure have broken balances. The windows will not stay in the desired position without a prop. Repairs are necessary as windows with broken balances are a potential safety hazard and eliminate an egress in the event of a fire.

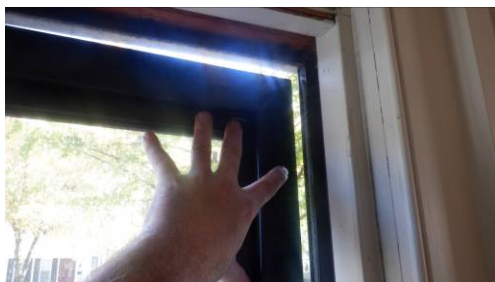
- **Attention:** The exterior storm doors are in need of minor fit adjustments. A further evaluation by qualified contractor is recommended.

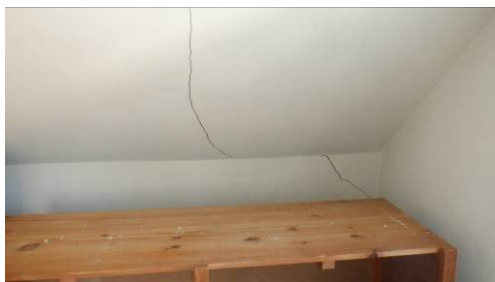
- **Action required:** Some of the upper plaster walls/ceilings were damaged and in need of repair to prevent further cracking and damage. There was significant cracking in the upper right rear plaster walls. This may be an indication of structural defects. Contact a licensed structural engineer to make a further evaluation and any necessary repairs to ensure proper structural support.

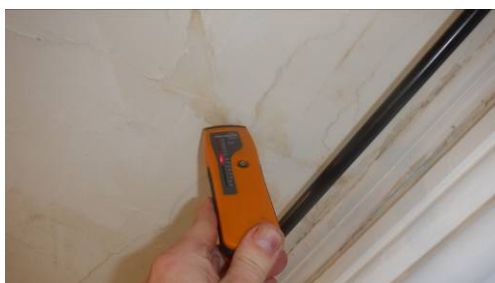
- **Action required:** Current moisture intrusion was noted on the master bathroom ceiling above the front window. This may be due to rotted trim of poor/failing flashing around the dormer. A further evaluation by a qualified contractor is recommended.

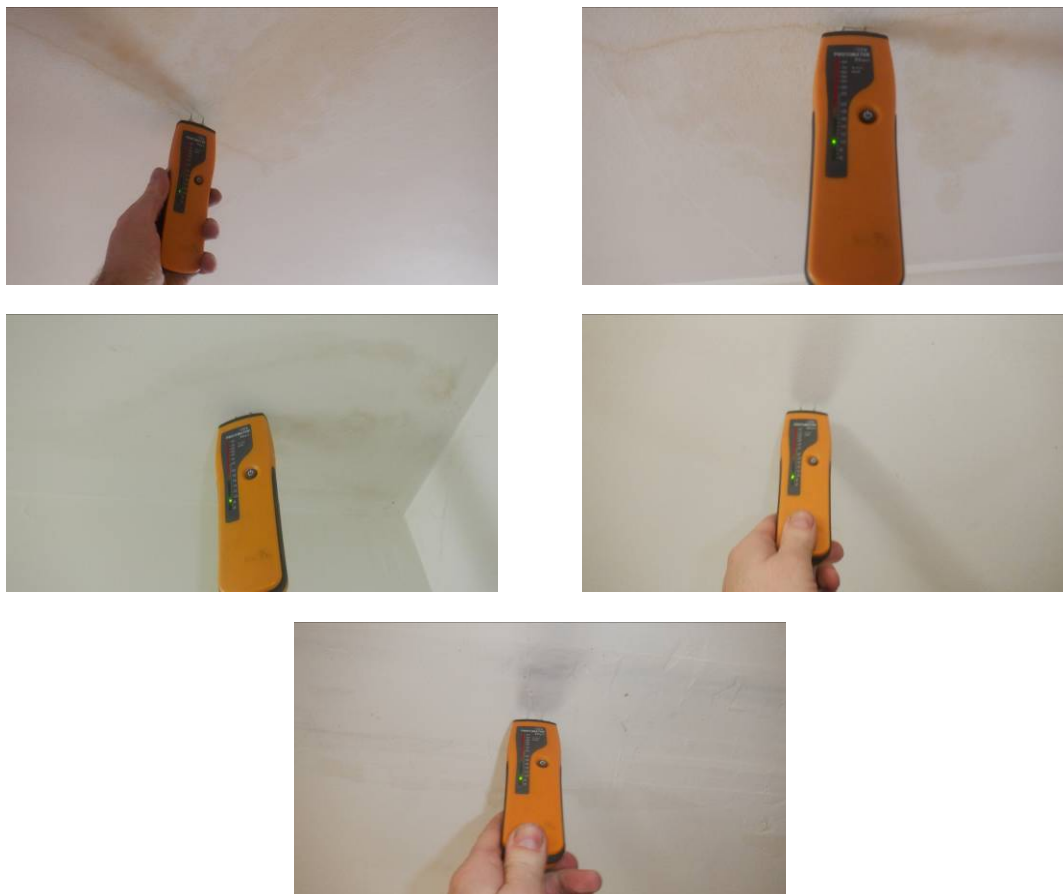
- **Action required:** There were moisture stains evident on the living room ceiling, kitchen ceiling, and rear lower close ceiling that tested dry at the time of the inspection. The exact origins could not be confirmed. A further evaluation by a qualified contractor is recommended.

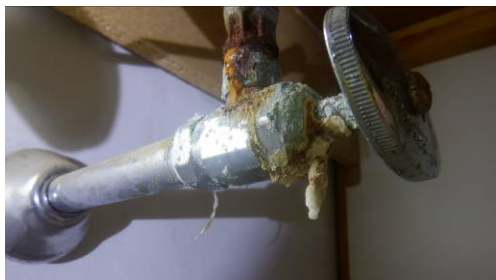
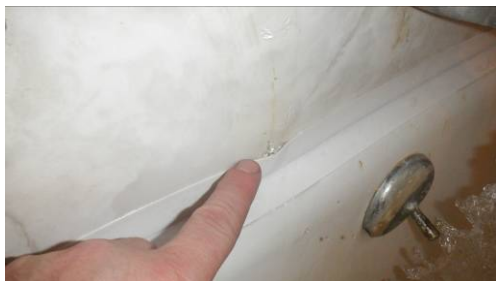
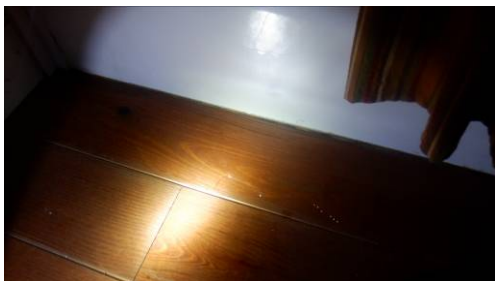
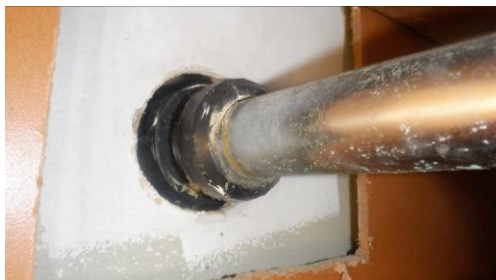
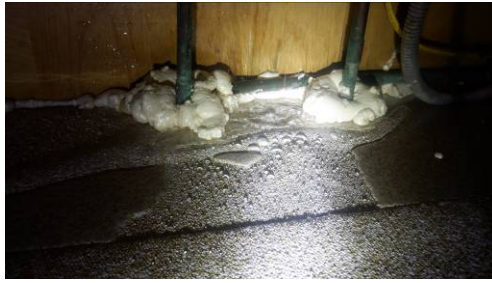
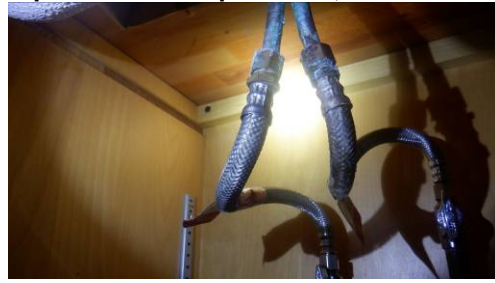
• **Action required:** An inspection of the readily accessible sections of the plumbing water supply, waste pipes, faucets and fixtures identified visible leak (s) that require repair at this time. The water was left running for approximately 10 minutes and the toilets were flushed at least 4 times at the time of the inspection. The inspector discovered current leaking at the right side master bathroom sink drain connection, right side master bathroom sink supply connection, the lower bathroom shower diverters, the lower bathroom sink drain connection, the kitchen sink diverter supply connections, The wet bar supply connections, the main copper supply connections in the basement, and several copper supply lines in the basement. In addition, the lower bathroom sink was dripping continuously in the OFF position. Repairs are recommended to prevent further deterioration and subsequent damage. Contact a licensed plumber to make a FULL technically exhaustive evaluation and the necessary repairs prior to transfer of ownership.

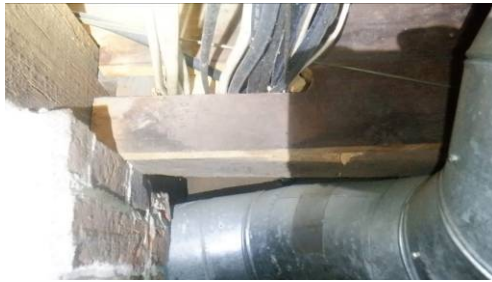
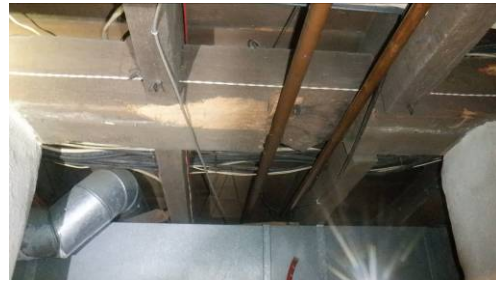
- **Action required:** There was visible deflection evident in the basement main beam and several of the floor joists. The main beam has been improperly notched and a significant amount of powder post beetle damage was noted. The deflection appeared to be carried to the floors above. The beam/joists appear to be in need of additional support. Contacting an individual qualified in structural repair or a licensed structural engineer is recommended for further evaluation and recommendations for repairs.

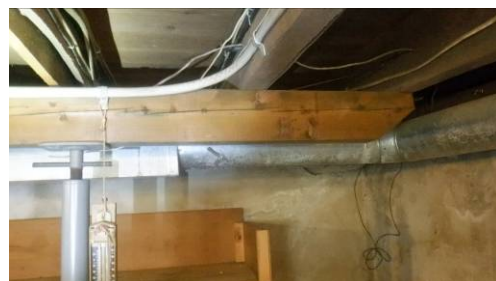
- **Action required:** There have been several temporary screw jack columns added in the basement that are not on any footings and are sitting on top of the floor slab, which is not designed to hold the weight. Footings are necessary to properly support the weight from above. In addition, the plates were not properly secured to girders with bolts. Furthermore, these columns are for temporary use not permanent use. It should also be noted that the columns were not properly installing at the end barring which is causing additional sagging. Contact a licensed structural engineer to make a further evaluation and the necessary repairs to ensure proper structural support.

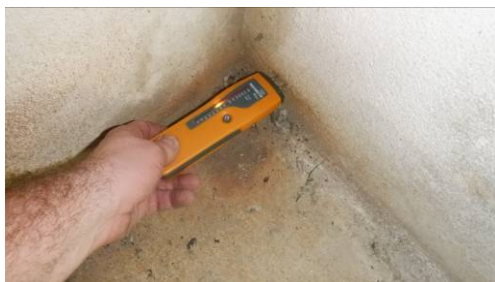
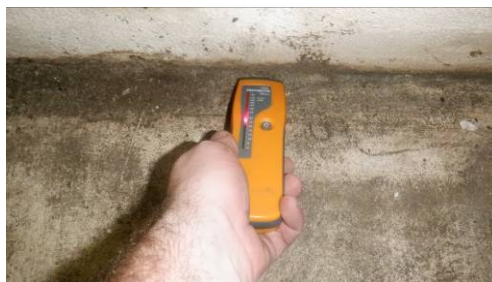
- **Action required:** There is evidence of minor present moisture penetration through the basement foundation walls. This was confirmed with a moisture meter. Exterior grade corrections, downspout extensions, the use of dehumidifiers, and waterproof paint coatings at the interior walls are recommended to reduce the amount of water penetration. Consulting with a qualified waterproofing company should be considered prior to transfer of ownership.
