# Building Inspection Report

123 Sample Street Sample Town, NJ 12345

04/04/2022

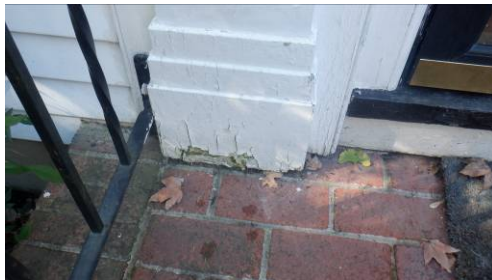
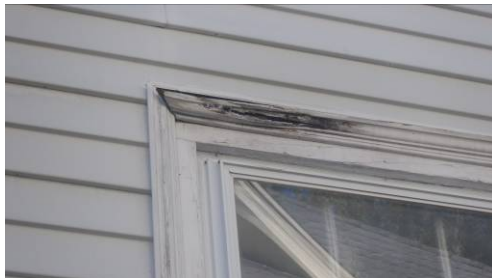
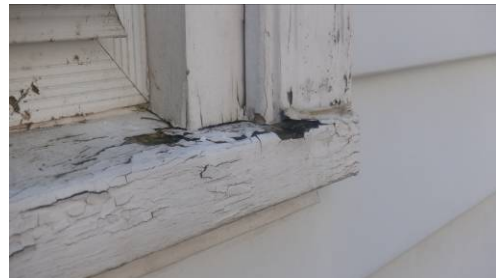
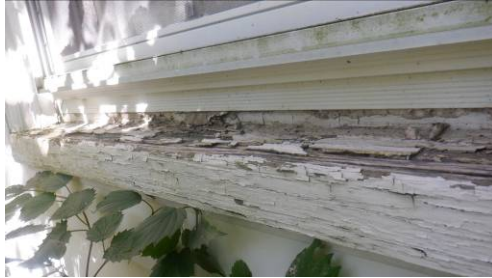
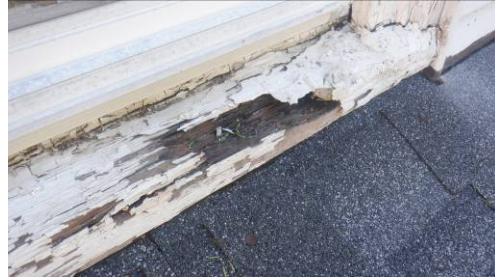
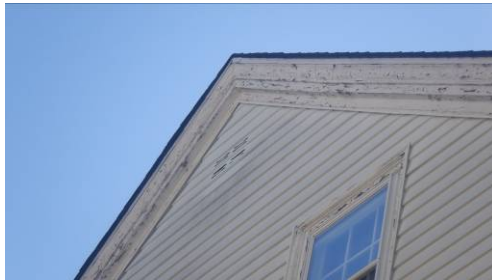
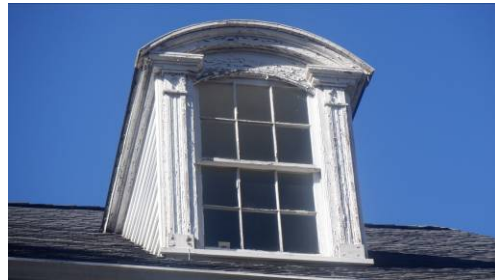
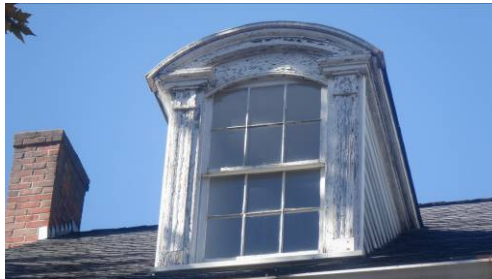
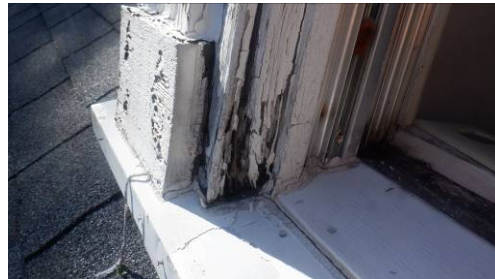
### **Eaves/Soffits/Trim/Fascia:**

- **Action required:** There was a significant amount of wood rot noted to the window trim and sills around the structure. Repairs are necessary at this time to prevent further deterioration and possible moisture intrusion. There may be areas of hidden damage not visible due to the non-invasive nature of this inspection. Consideration should be given to wrapping exposed exterior wood with aluminum to reduce maintenance. Contact a qualified contractor to make a further evaluation and the necessary repairs.

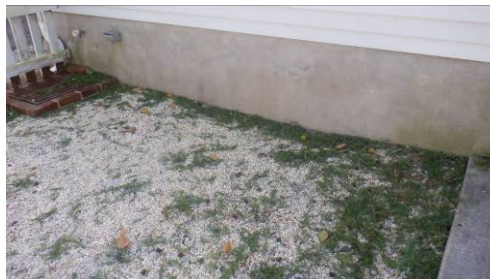
**Site Drainage:**

- **Action required:** There are portions of the site grading, around the foundation perimeter, that are sloping excessively toward the structure. Corrections to the exterior site grading are necessary to prevent foundation water penetration. Grade pitch of 1" drop over 12" of run, sloping away from the structure, is most desired. Drains and downspouts extending 6' away from the house is optimum. Proper site drainage is a preventative maintenance measure to any foundation system. Consulting with a landscaping company may be considered for help with site grading.

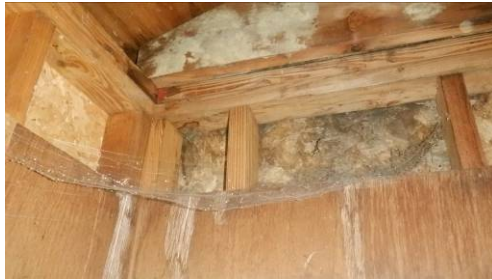
**Roof Material Condition:**

- **Action required:** There are indications the roof system is currently leaking. Current leaking was discovered in the back left corner of the garage. The area tested wet at the time of the inspection. Repairs are necessary. Contacting a qualified roofing contractor for full evaluation and repairs is necessary.

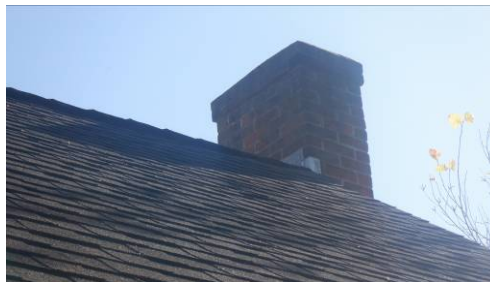
**Chimney (s) and Vents/covers:**

- **Action required:** Capping off or discontinuing the abandon chimney is recommended to prevent possible moisture or animal intrusion. A further evaluation by a qualified chimney contractor is recommended prior to transfer of ownership.

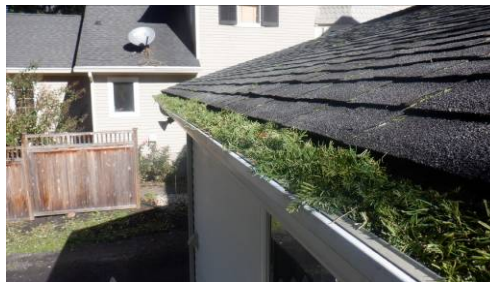
**Gutters & Downspouts**

- **Action required:** There is debris build up in the gutters that should be removed. Debris can clog the gutters, down spouts, and/or drain system if not cleaned out. Cleaning the gutters on an annual basis is recommended for proper care and maintenance of the gutter system.

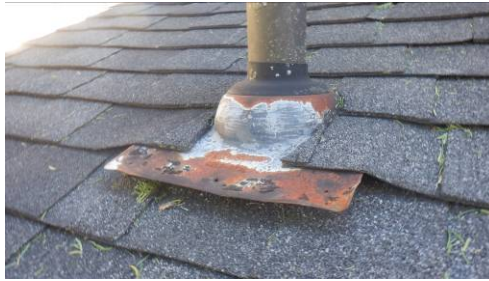
**Flashing/Caulking:**

- **Action required:** Securing and sealing the rear sewer vent flashing is recommended to prevent possible moisture intrusion. A further evaluation by a qualified roofing contractor is recommended.

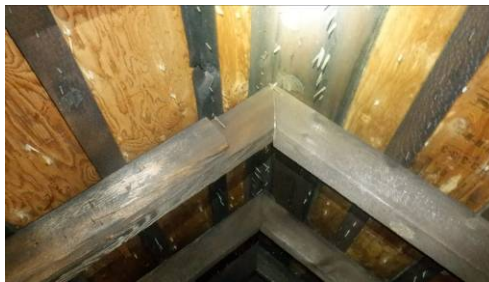
**Ventilation:**

- **Action required:** Attic areas should be vented with half of the ventilating area near the high point of the roof and the other half near the eaves. The ratio of the vent to floor space is 1/300th of the main floor. To help achieve this ratio, the inspector recommends pulling the insulation back from the eaves and installing rafter vents, to allow the air to flow through the soffit vents and into the attic. It should also be noted that a ridge vent was installed but the sheathing has not been properly cut. This defeats the purpose of the ridge vent. Contact a qualified contractor to make a further evaluation and the necessary modifications.

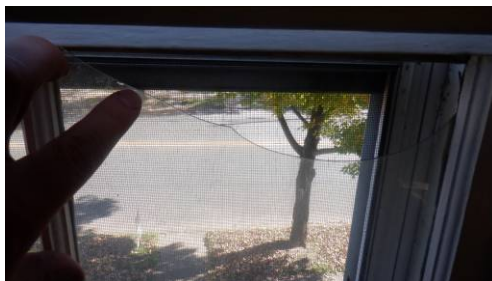
**Windows:**

- **Action required:** There is loose broken/missing glass at several of the windows that could result in an injury. Repairs are necessary for safety.

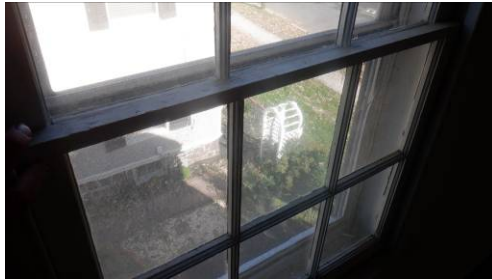
- **Action required:** A random test of the windows was done to see if they could be latched/locked and opened/closed. The test revealed that the majority of the older windows in the structure have broken balances. The windows will not stay in the desired position without a prop. Repairs are necessary as windows with broken balances are a potential safety hazard and eliminate an egress in the event of a fire.

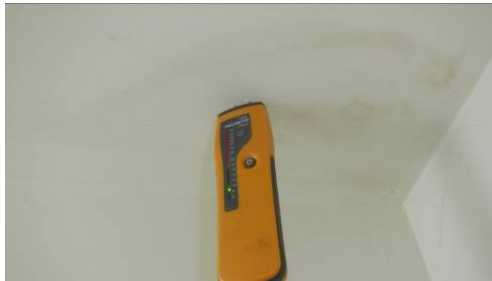
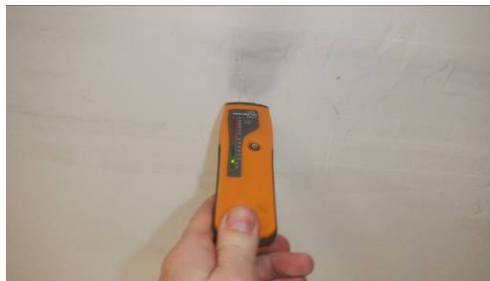
- **Action required:** There were moisture stains evident on the living room ceiling, kitchen ceiling, and rear lower close ceiling that tested dry at the time of the inspection. The exact origins could not be confirmed. A further evaluation by a qualified contractor is recommended.

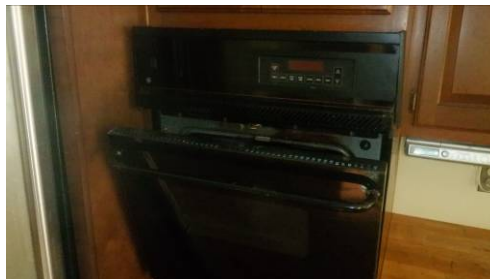
**Kitchen Area:**

- **Action required:** The oven was not working at the time of the inspection. Repair/replacement appears to be necessary. A further evaluation by a qualified contractor is recommended.

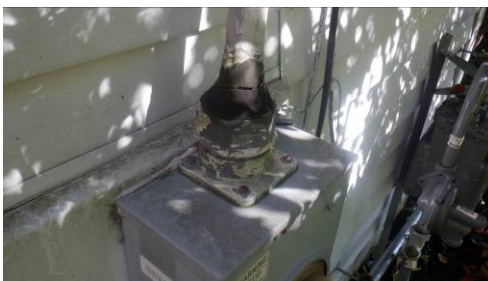
**Service / Entrance**

- **Action required:** The putty around the service line where it enters the meter was deteriorated. Repairs are necessary to prevent possible moisture intrusion in the panel. Contact the utility supplier or a licensed electrician for final determination.

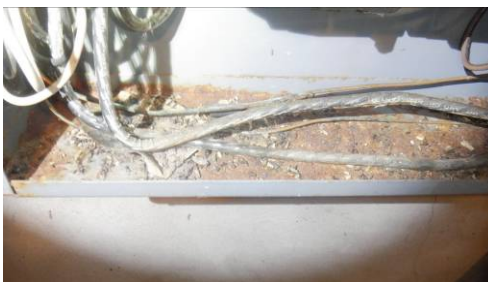
**Main Panel**

- **Action required:** The panel cover was removed and it appears that water has penetrated the panel at some time in the past and as a result oxidation is present at the main lugs and other connections. Rust and mouse dropping was also noted in the base of the panel. The inspector recommends a licensed electrician further evaluate the electrical panel and make recommendations for proper repairs, if needed.

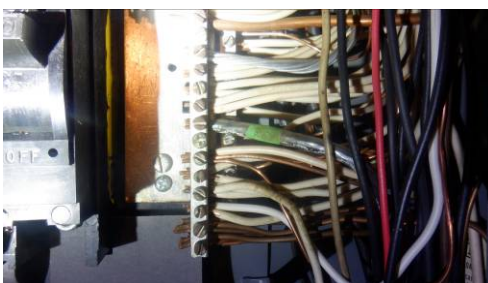
- **Action required:** The inspector discovered one or more neutral wires connected to the same screw in the panel. All neutral and ground wires must be under separate screws according to today's standards. Contacting a licensed electrician is necessary for corrections.

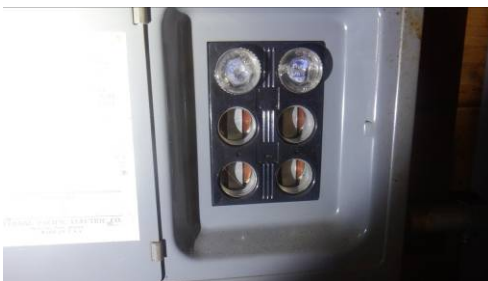
**Auxiliary Panel(s)**

- **Action required:** One of the sub-panels in the garage contained buss fuses. This is not a recommended arrangement according to today's standards. Installing breakers is recommended. Contact a licensed electrician to make a further evaluation and the necessary modifications.

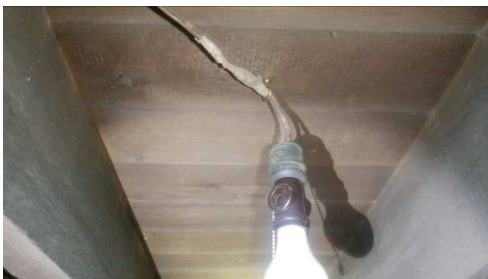
**Plugs, Switches, Junction boxes:**

- **Action required:** There are exposed splices/wire connections and extension cord splices to light fixtures in the basement. This may pose a fire hazard. Contact a licensed electrician to make a further evaluation and the necessary repairs.

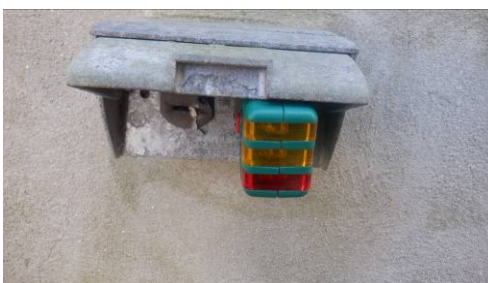
- **Action required:** The rear exterior receptacle was not showing power at the time of the inspection. A further evaluation by a licensed electrician is recommended.

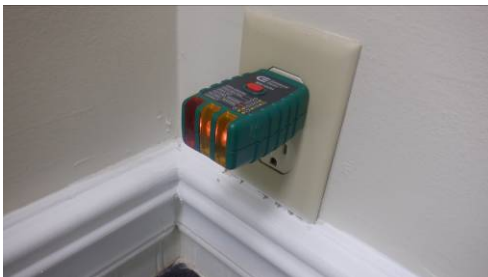
#### G.F.C.I Outlets:

- **Action required:** The majority of the bathroom and kitchen outlets have been GFCI protected as a preventive safety upgrade. Current electrical requirements require that Ground Fault Circuit Interrupters (GFCI) be located in areas where there is a higher potential danger of electrical shock (bathroom, exterior and kitchen outlets). The age of the structure may predate the adoption of this requirement. Consideration should be given to installing GFCI protection to the right of the MASTER BATHROOM SINK where there is a higher potential for electrical shock. A further evaluation by a licensed electrician is recommended.

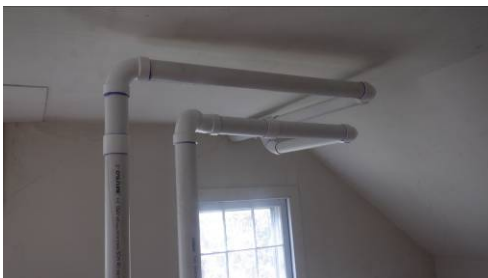
#### Exhaust Flues and Vents:

- **Action required:** Properly securing the 2<sup>nd</sup> zone heating system exhaust flue with hangers is necessary for safety. Contact a qualified HVAC technician to make a further evaluation and the necessary modifications.

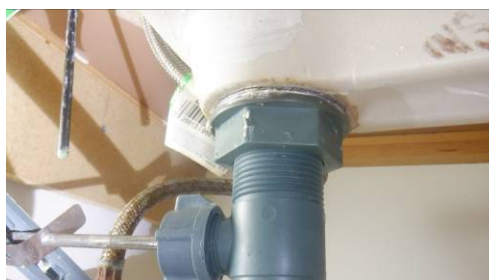
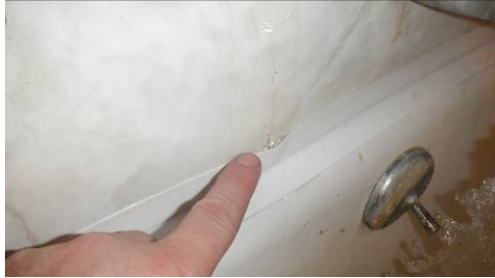
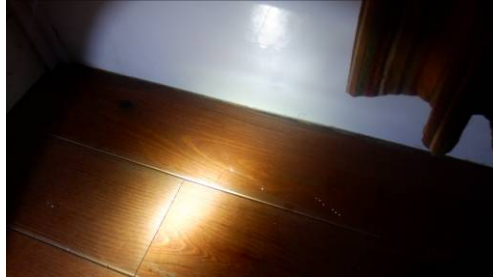
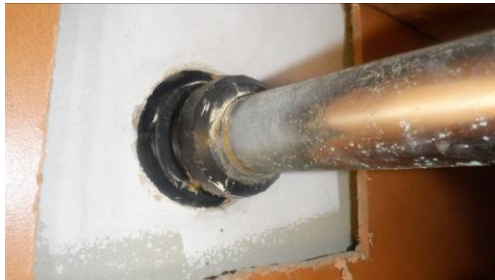
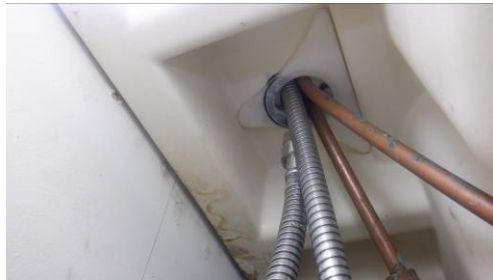
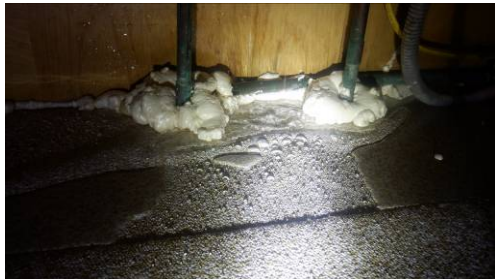
#### Evidence of Plumbing Leaks:

- **Action required:** An inspection of the readily accessible sections of the plumbing water supply, waste pipes, faucets and fixtures identified visible leak (s) that require repair at this time. The water was left running for approximately 10 minutes and the toilets were flushed at least 4 times at the time of the inspection. The inspector discovered current leaking at the right side master bathroom sink drain connection, right side master bathroom sink supply connection, the lower bathroom shower diverters, the lower bathroom sink drain connection, the kitchen sink diverter supply connections, The wet bar supply connections, the main copper supply connections in the basement, and several copper supply lines in the basement. In addition, the lower bathroom sink was dripping continuously in the OFF position. Repairs are recommended to prevent further deterioration and subsequent damage. Contact a licensed plumber to make a FULL technically exhaustive evaluation and the necessary repairs prior to transfer of ownership.

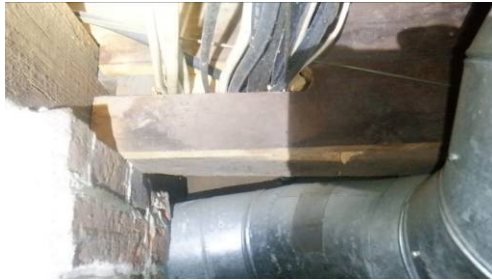
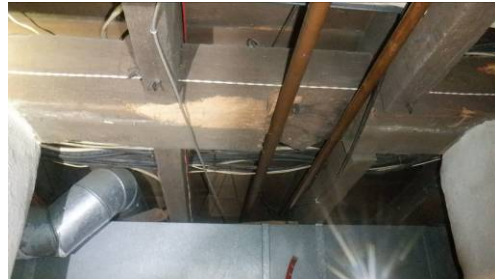
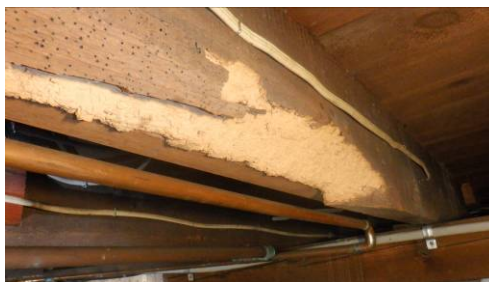
**Visible Basement Floor Structure:**

- **Action required:** There was visible deflection evident in the basement main beam and several of the floor joists. The main beam has been improperly notched and a significant amount of powder post beetle damage was noted. The deflection appeared to be carried to the floors above. The beam/joists appear to be in need of additional support. Contacting an individual qualified in structural repair or a licensed structural engineer is recommended for further evaluation and recommendations for repairs.

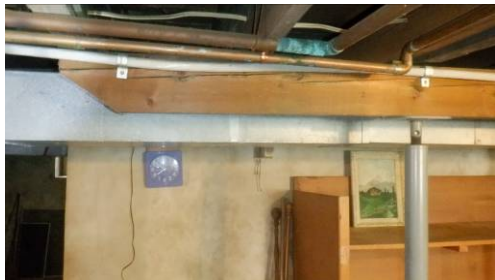
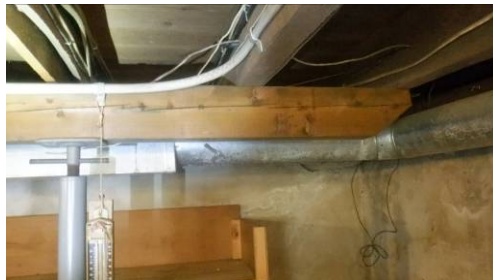
- **Action required:** There have been several temporary screw jack columns added in the basement that are not on any footings and are sitting on top of the floor slab, which is not designed to hold the weight. Footings are necessary to properly support the weight from above. In addition, the plates were not properly secured to girders with bolts. Furthermore, these columns are for temporary use not permanent use. It should also be noted that the columns were not properly installing at the end barring which is causing additional sagging. Contact a licensed structural engineer to make a further evaluation and the necessary repairs to ensure proper structural support.

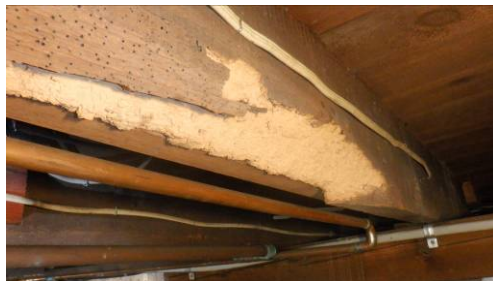
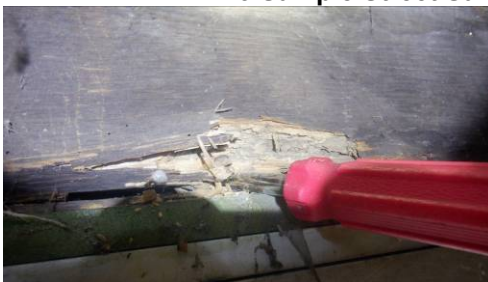
**Evidence of Insects:**

- **Action required:** The inspector discovered excessive powder post beetle and termite damage/activity in the basement. A full wood destroying insect infestation inspection is recommended to determine the need for treatment and/or repair. There may be areas of hidden damage not visible due to the non-invasive nature of this inspection.

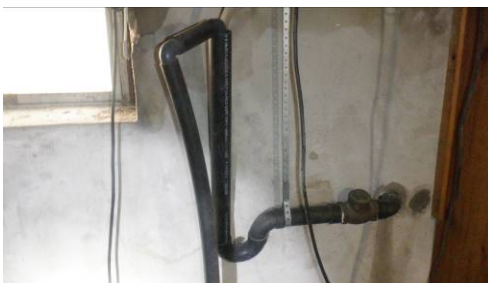
**Ductwork and Piping:**

- **Action required:** The sump pump is currently draining directly into the sewer line. This may not be acceptable according to local ordinances. Extending the sump pump drain to the exterior should be considered. Verifying this during the certificate of occupancy inspection is recommended.

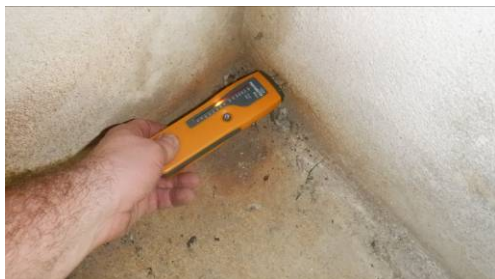
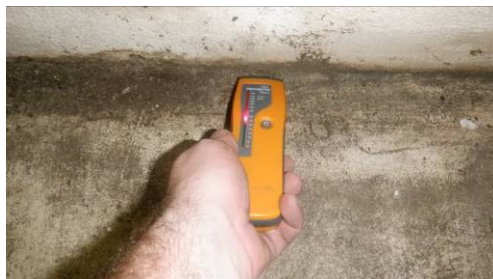
**Basement Moisture:**

- **Action required:** There is evidence of minor present moisture penetration through the basement foundation walls. This was confirmed with a moisture meter. Exterior grade corrections, downspout extensions, the use of dehumidifiers, and waterproof paint coatings at the interior walls are recommended to reduce the amount of water penetration. Consulting with a qualified waterproofing company should be considered prior to transfer of ownership.

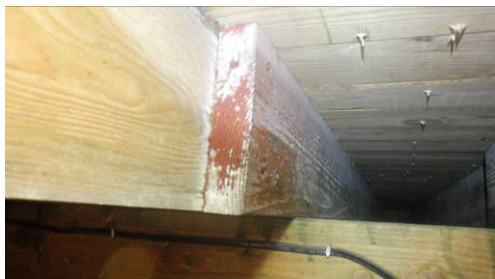
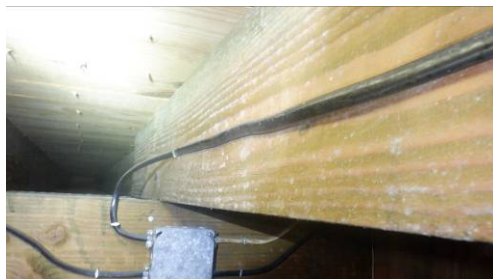
**Crawl Space Area:**

- **Action required:** Crawl spaces should be properly vented to reduce moisture levels. There was currently moisture intrusion and possible development of mold in the crawl space at the time of the inspection. Action should be taken to create better ventilation or dehumidification for the crawl space area to reduce the excessive moisture levels. Cleaning the areas with possible development of mold is also recommended to prevent a possible allergic reaction. A further evaluation by a qualified contractor is recommended prior to transfer of ownership.

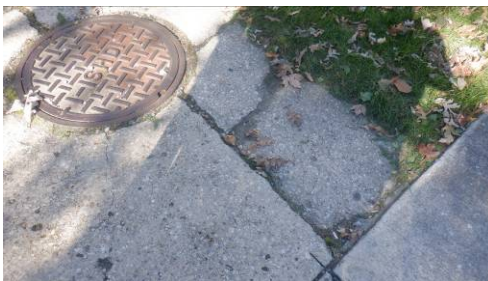
### Site Concrete and Paving:

- **Attention:** It will be necessary to seal the cracks in the walkways and driveway to prevent water from penetrating below the surface and causing further cracking.

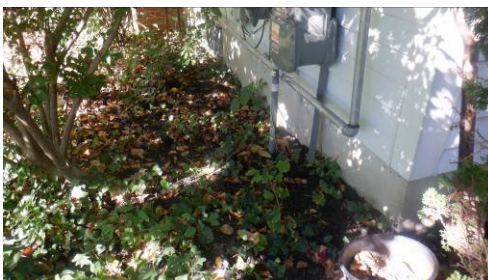
### Window/Vent Wells:

- **Attention:** Adding window wells around the basement windows is recommended to provide better site grade and prevent water penetration through the basement windows.

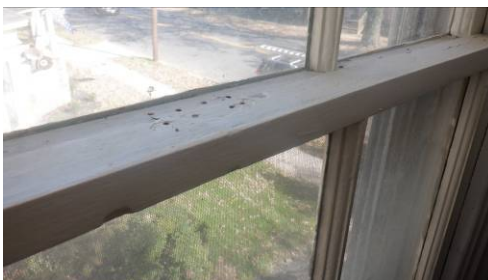
### Windows:

- **Attention:** Some of the storm window frames are in need of weep holes to allow driven rain to exit the window sill area.
- **Attention:** A random test of the windows was done to see if they could be latched/locked and opened/closed. The inspection revealed one or more windows with missing or broken locks which should be replaced or repaired in order to provide security. This is only a random test and in no way a guarantee that all windows are functional. Most windows will need periodic adjustments.

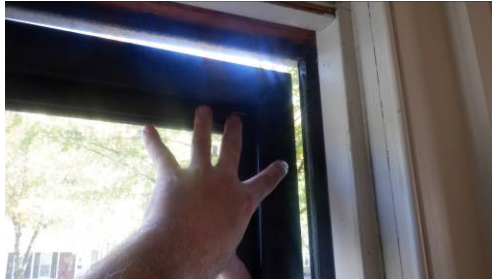
**Doors:**

- **Attention:** The exterior storm doors are in need of minor fit adjustments. A further evaluation by qualified contractor is recommended.

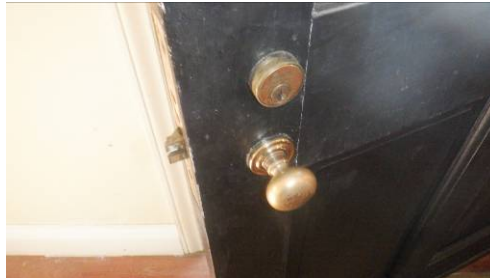
- **Attention:** There was a key lock installed for the rear exterior door. This is not a recommended arrangement due to the difficulty of egress in the event of an emergency. Installing a standard dead bolt is recommended. Contact a qualified contractor to make a further evaluation and the necessary modifications.

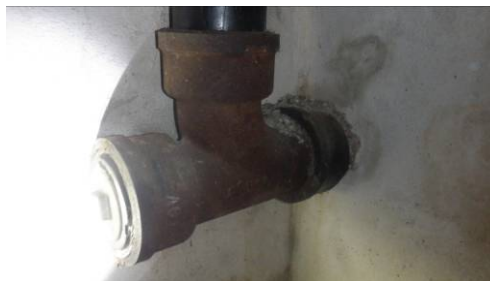
**Waste Plumbing System:**

- **Attention:** The inspector recommends questioning the seller to determine the extent of the updates to the original sewer drain pipe from the house to the city sewer main. The sewer main line appears to be Cast Iron. Cast Iron piping typically has a serviceable life of 50 years and up. This inspection does not cover failure to sewer lines due to their inaccessibility to inspection. Periodic clearing of cast iron drain piping is often needed due to debris becoming stuck to the rough inside of the piping. Having the main sewer line from the house to the street professionally scoped with a camera is also strongly recommended as defects may exist.

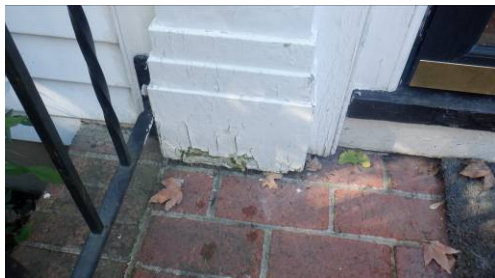
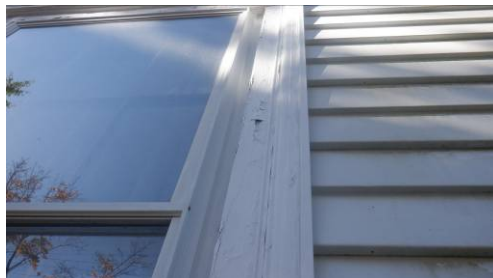
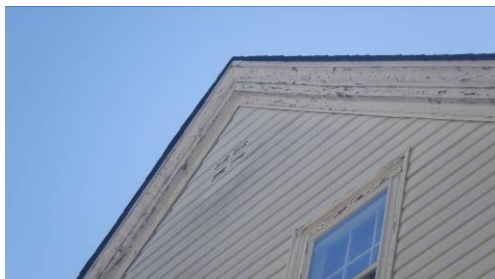
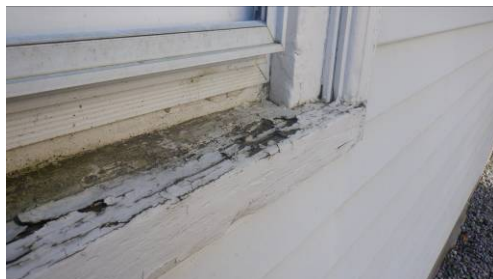
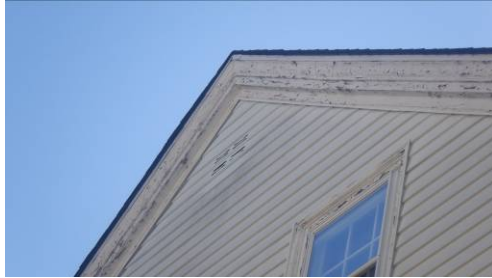
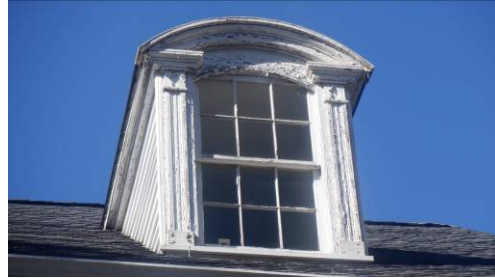
#### Eaves/Soffits/Trim/Fascia:

- **Action required:** There was a significant amount of wood rot noted to the window trim and sills around the structure. Repairs are necessary at this time to prevent further deterioration and possible moisture intrusion. There may be areas of hidden damage not visible due to the non-invasive nature of this inspection. Consideration should be given to wrapping exposed exterior wood with aluminum to reduce maintenance. Contact a qualified contractor to make a further evaluation and the necessary repairs.

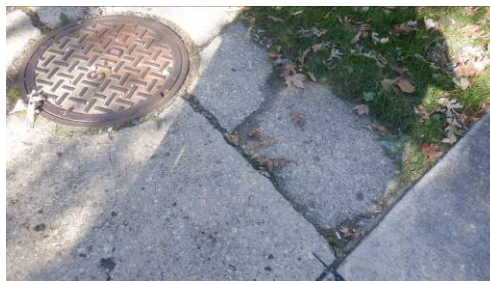
**Site Concrete and Paving:**

- **Attention:** It will be necessary to seal the cracks in the walkways and driveway to prevent water from penetrating below the surface and causing further cracking.

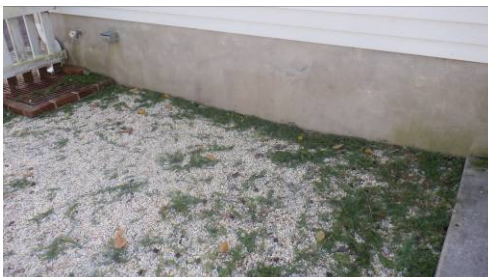
**Site Drainage:**

- **Action required:** There are portions of the site grading, around the foundation perimeter, that are sloping excessively toward the structure. Corrections to the exterior site grading are necessary to prevent foundation water penetration. Grade pitch of 1" drop over 12" of run, sloping away from the structure, is most desired. Drains and downspouts extending 6' away from the house is optimum. Proper site drainage is a preventative maintenance measure to any foundation system. Consulting with a landscaping company may be considered for help with site grading.

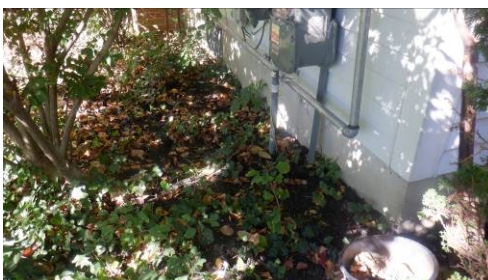
**Window/Vent Wells:**

- **Attention:** Adding window wells around the basement windows is recommended to provide better site grade and prevent water penetration through the basement windows.

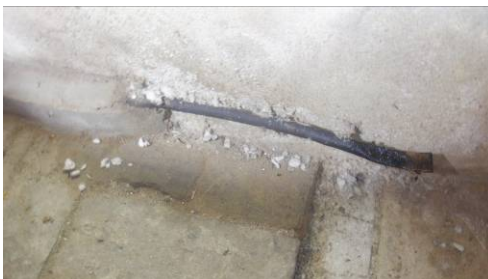
- The inspector was unable to verify the presence or absence of an underground heating oil storage tank on the property. There was no filler pipe opening, plumbing or vent piping used by an underground storage tank (UST) visible to the inspector that would verify a heating oil tank is buried on the property. Questioning the seller regarding any known underground oil tanks is recommended.

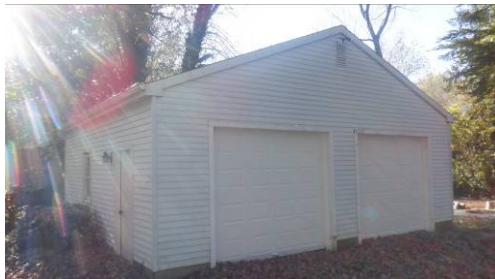
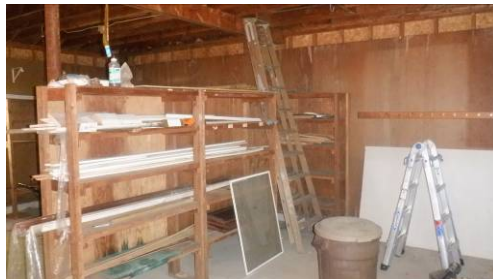
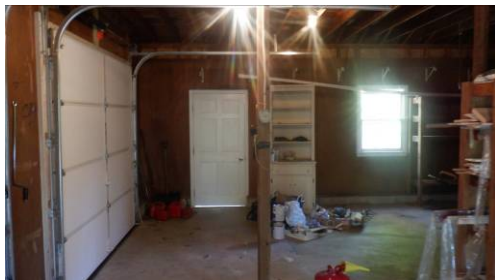
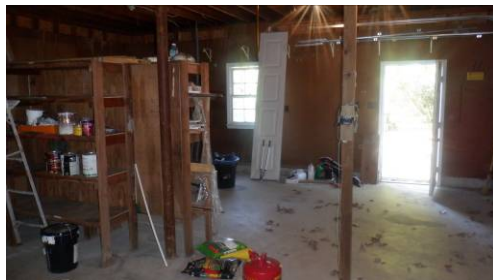
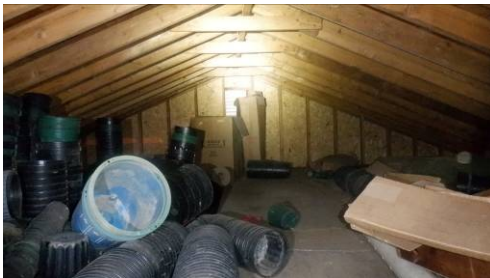
**General Comments:**

- The amount of items stored in the garage limited a full visual inspection. A further evaluation at the final walk-through is strongly recommended as defects may exist.

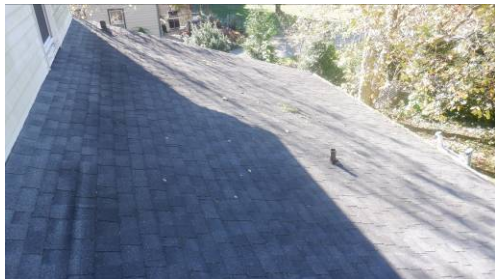
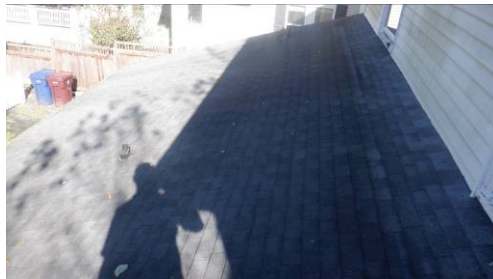
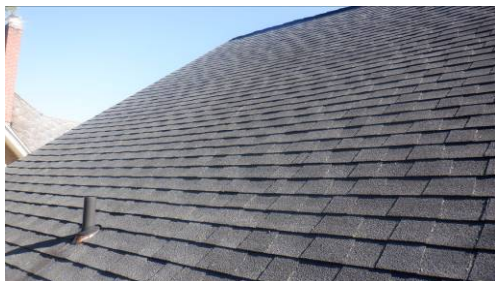
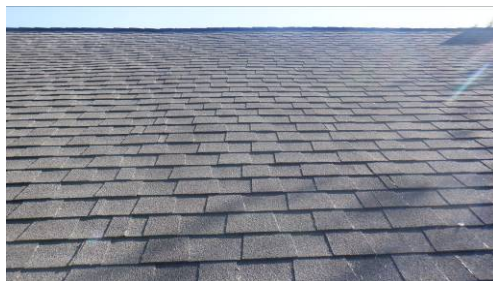
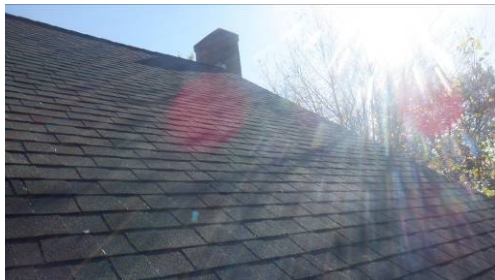
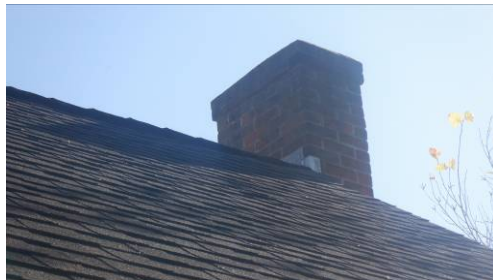
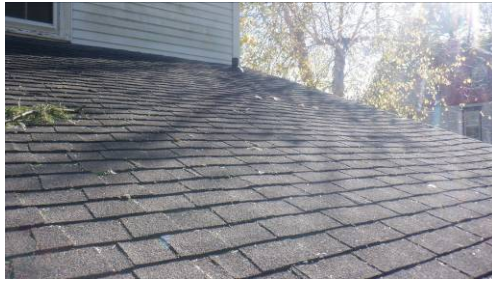
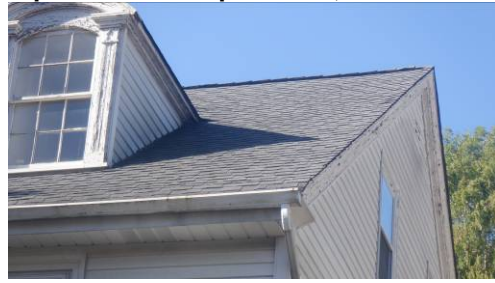
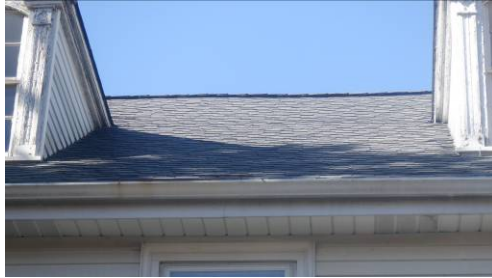
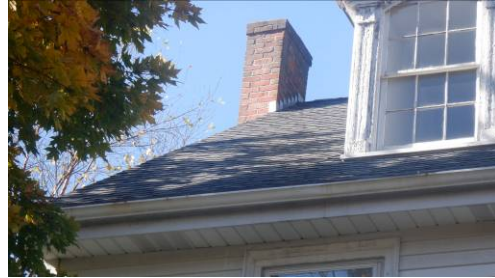
- The typical life expectancy of this type of roof material is 15-20 years from the date of installation.

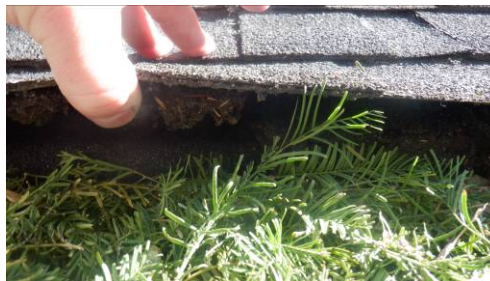
- Multiple roofing layers were noted. Only up to 2 layers of roofing material are allowing as per local ordinances, as well as to help prevent damage to the roof sub-structure from excessive weight. At time of re-surfacing, all roofing layers will need to be removed.

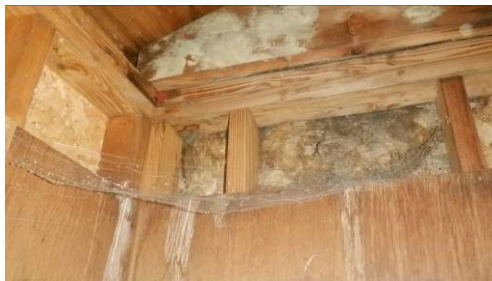
- **Action required:** There are indications the roof system is currently leaking. Current leaking was discovered in the back left corner of the garage. The area tested wet at the time of the inspection. Repairs are necessary. Contacting a qualified roofing contractor for full evaluation and repairs is necessary.

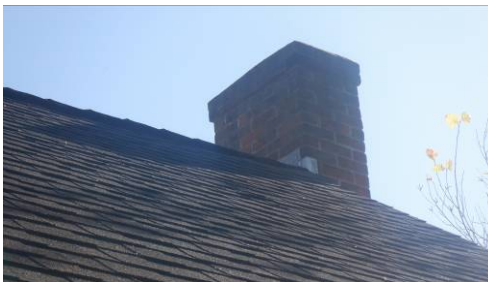
- **Action required:** Capping off or discontinuing the abandon chimney is recommended to prevent possible moisture or animal intrusion. A further evaluation by a qualified chimney contractor is recommended prior to transfer of ownership.

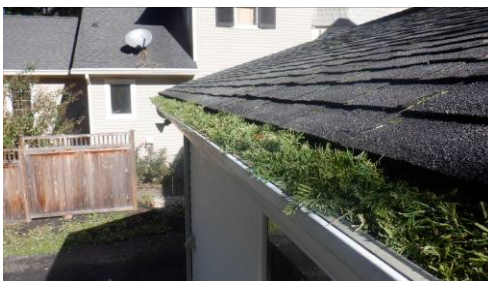
- **Action required:** There is debris build up in the gutters that should be removed. Debris can clog the gutters, down spouts, and/or drain system if not cleaned out. Cleaning the gutters on an annual basis is recommended for proper care and maintenance of the gutter system.

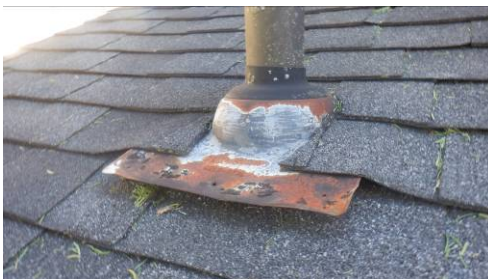
- **Action required:** Securing and sealing the rear sewer vent flashing is recommended to prevent possible moisture intrusion. A further evaluation by a qualified roofing contractor is recommended.

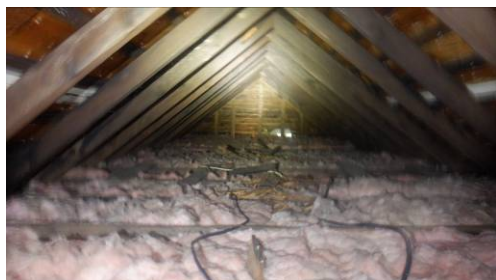
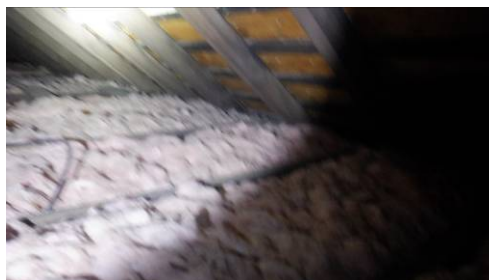
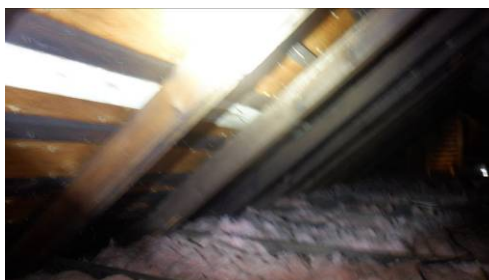
- Consideration may be given to adding an attic fan to increase ventilation in the attic area and reduce high temperatures that could reduce the life expectancy of the roof surface material.
- There were areas of the attic that were inaccessible to the inspector due to reduced clearance and obstruction by structural members, notably at the eaves. These areas could not be inspected due to the reduced clearance.

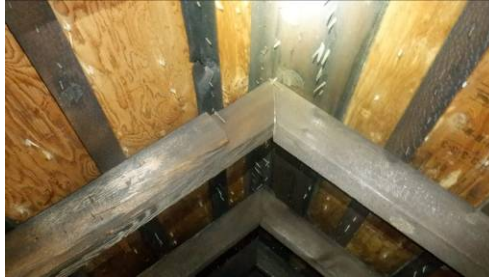
- **Action required:** Attic areas should be vented with half of the ventilating area near the high point of the roof and the other half near the eaves. The ratio of the vent to floor space is 1/300th of the main floor. To help achieve this ratio, the inspector recommends pulling the insulation back from the eaves and installing rafter vents, to allow the air to flow through the soffit vents and into the attic. It should also be noted that a ridge vent was installed but the sheathing has not been properly cut. This defeats the purpose of the ridge vent. Contact a qualified contractor to make a further evaluation and the necessary modifications.

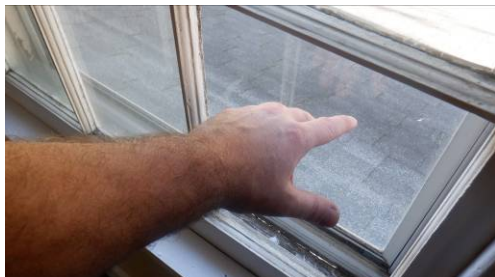
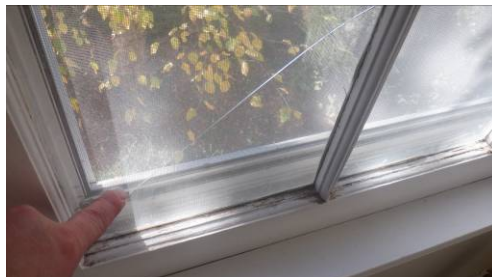
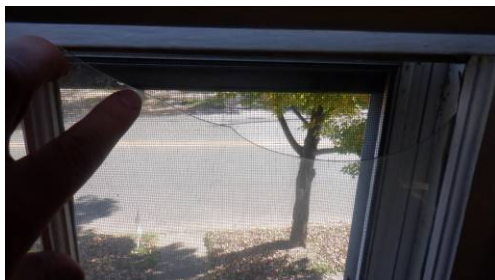
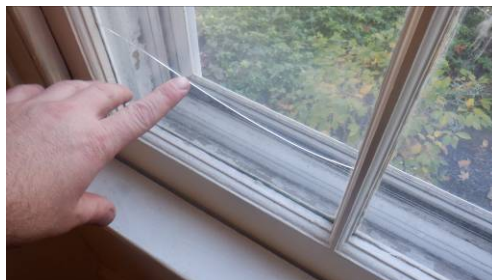
- **Attention:** The single pane windows have glazing compound, used to hold the glass in place, that will be in need of replacing at some areas in the near future as a routine preventive maintenance item. Window glazing compound is inexpensive and can be applied with a putty knife.
- **Action required:** There is loose broken/missing glass at several of the windows that could result in an injury. Repairs are necessary for safety.

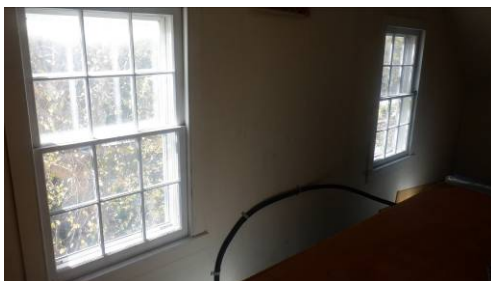
- **Action required:** A random test of the windows was done to see if they could be latched/locked and opened/closed. The test revealed that the majority of the older windows in the structure have broken balances. The windows will not stay in the desired position without a prop. Repairs are necessary as windows with broken balances are a potential safety hazard and eliminate an egress in the event of a fire.

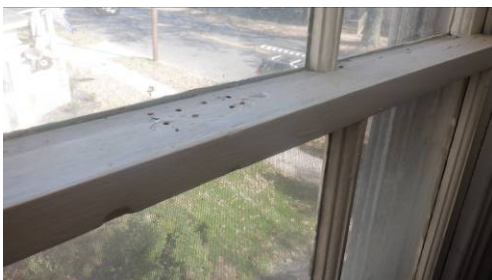
- **Attention:** A random test of the windows was done to see if they could be latched/locked and opened/closed. The inspection revealed one or more windows with missing or broken locks which should be replaced or repaired in order to provide security. This is only a random test and in no way a guarantee that all windows are functional. Most windows will need periodic adjustments.

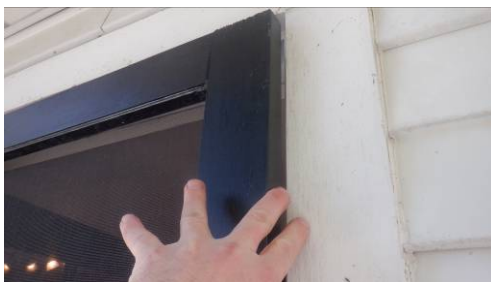
- **Attention:** The exterior storm doors are in need of minor fit adjustments. A further evaluation by qualified contractor is recommended.

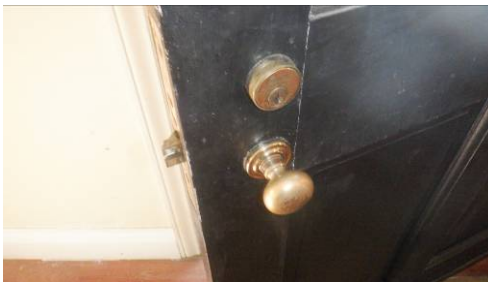
- **Attention:** There was a key lock installed for the rear exterior door. This is not a recommended arrangement due to the difficulty of egress in the event of an emergency. Installing a standard dead bolt is recommended. Contact a qualified contractor to make a further evaluation and the necessary modifications.

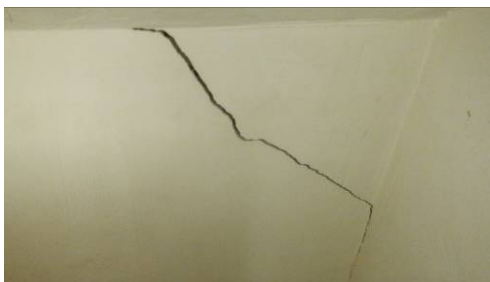
- **Action required:** Some of the upper plaster walls/ceilings were damaged and in need of repair to prevent further cracking and damage. There was significant cracking in the upper right rear plaster walls. This may be an indication of structural defects. Contact a licensed structural engineer to make a further evaluation and any necessary repairs to ensure proper structural support.

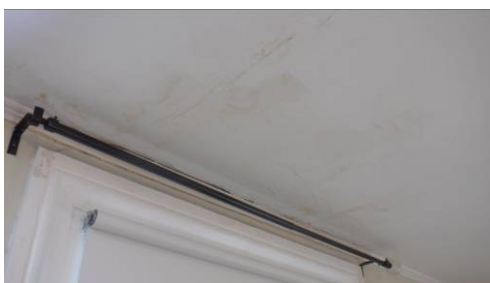
- **Action required:** Current moisture intrusion was noted on the master bathroom ceiling above the front window. This may be due to rotted trim of poor/failing flashing around the dormer. A further evaluation by a qualified contractor is recommended.

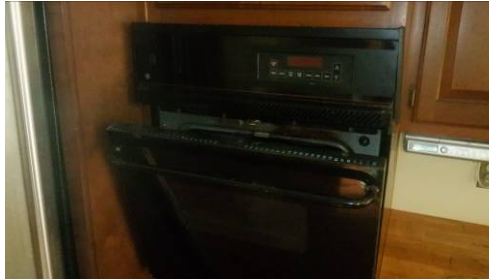
- **Action required:** The oven was not working at the time of the inspection. Repair/replacement appears to be necessary. A further evaluation by a qualified contractor is recommended.

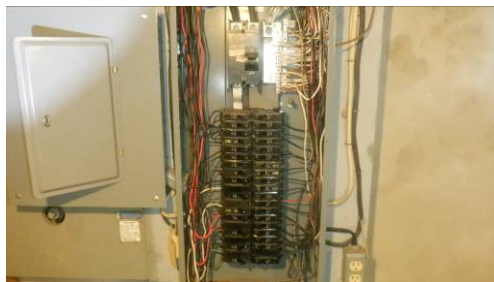
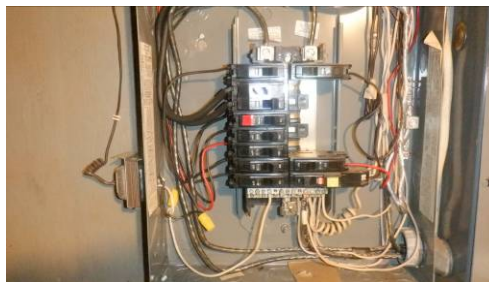
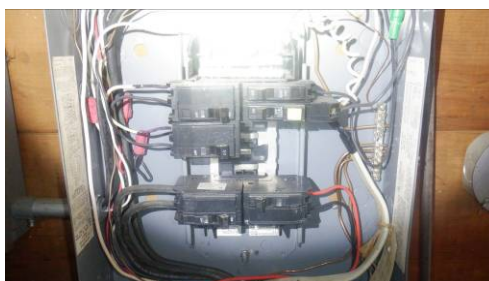
- The breakers are labeled, which allows quick identification of service disconnects in the event of an emergency.
- The inspector has SPOT CHECKED the three-prong female 120 volt electrical outlets throughout the structure, and has not found any that were not correctly grounded. NOTE! This is not a warranty and an undiscovered condition may exist. It should be noted that the inspector could not check all the outlets due to furniture that could not be moved.
- The wiring (where visible) has been updated to Romex wiring. No visible knob & tube wiring was evident. Questioning the seller regarding past electrical upgrades is recommended. There may still be knob & tube wiring present but not visible to the inspector.

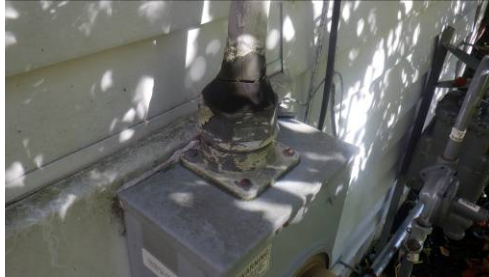
- **Action required:** The putty around the service line where it enters the meter was deteriorated. Repairs are necessary to prevent possible moisture intrusion in the panel. Contact the utility supplier or a licensed electrician for final determination.

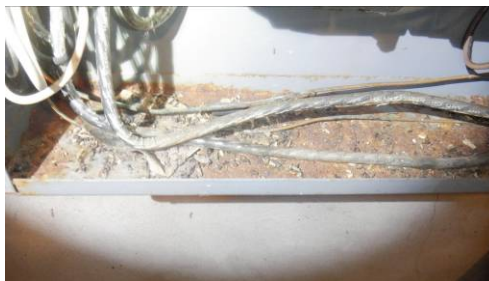
- **Action required:** The panel cover was removed and it appears that water has penetrated the panel at some time in the past and as a result oxidation is present at the main lugs and other connections. Rust and mouse dropping was also noted in the base of the panel. The inspector recommends a licensed electrician further evaluate the electrical panel and make recommendations for proper repairs, if needed.

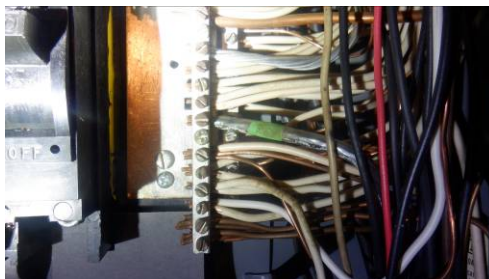
- **Action required:** The inspector discovered one or more neutral wires connected to the same screw in the panel. All neutral and ground wires must be under separate screws according to today's standards. Contacting a licensed electrician is necessary for corrections.

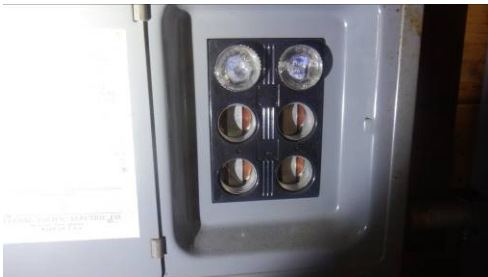
- **Action required:** One of the sub-panels in the garage contained buss fuses. This is not a recommended arrangement according to today's standards. Installing breakers is recommended. Contact a licensed electrician to make a further evaluation and the necessary modifications.

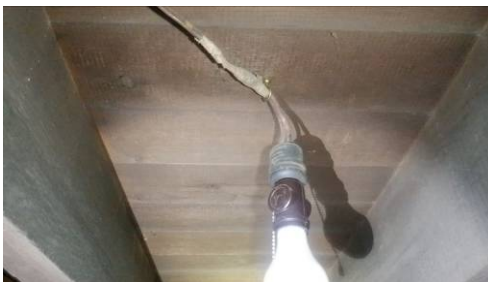
- **Action required:** There are exposed splices/wire connections and extension cord splices to light fixtures in the basement. This may pose a fire hazard. Contact a licensed electrician to make a further evaluation and the necessary repairs.

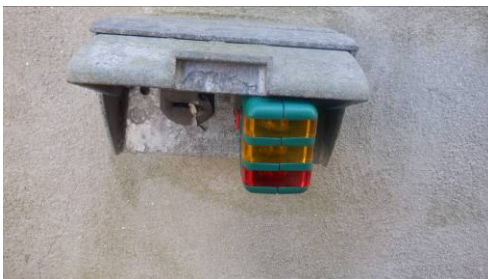
- **Action required:** The rear exterior receptacle was not showing power at the time of the inspection. A further evaluation by a licensed electrician is recommended.

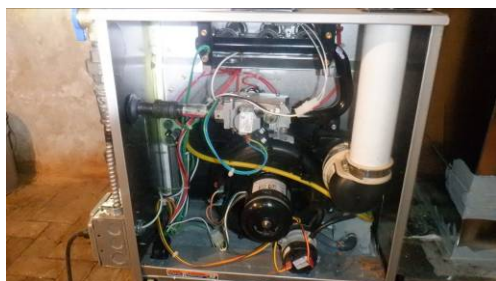
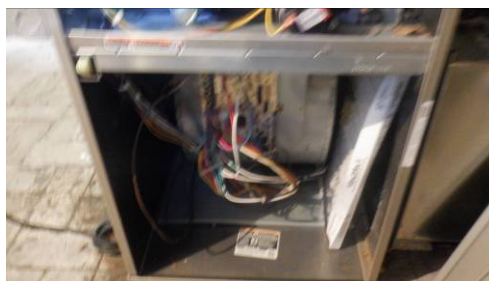
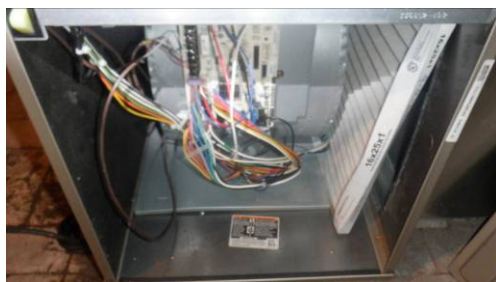
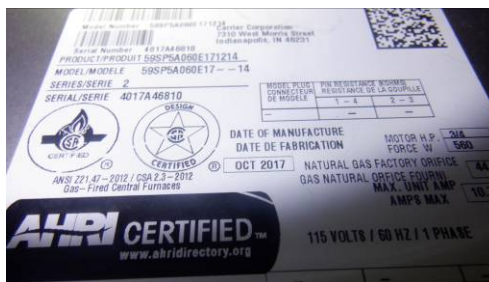
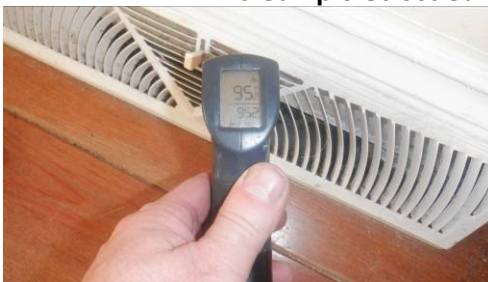
- **Attention:** The heating system was identified to be in working order at the time of the inspection. No service records were visible – questioning the seller regarding past service is recommended. A full technically exhaustive servicing is recommended for optimum efficiency. We recommend the heating and cooling systems be serviced on an annual basis.

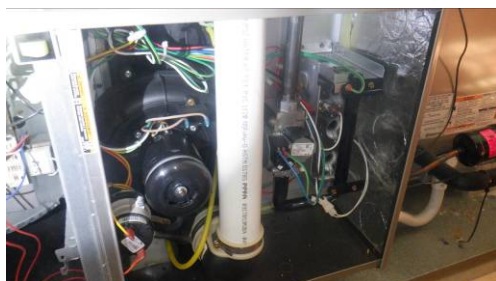
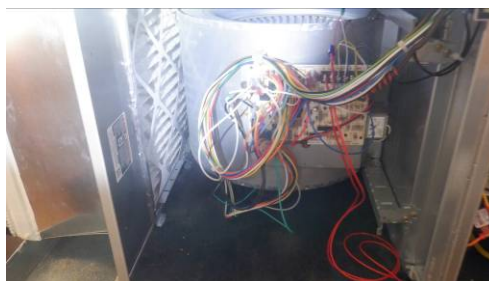
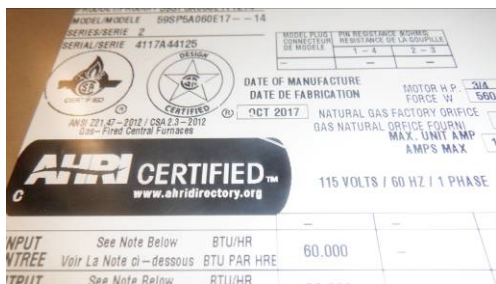
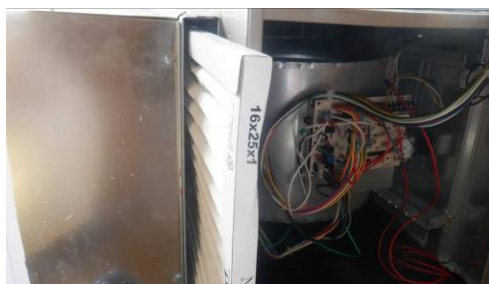
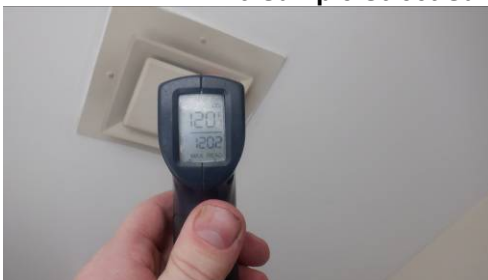
- **Attention:** The 2<sup>nd</sup> zone heating system was identified to be in working order at the time of the inspection. No service records were visible – questioning the seller regarding past service is recommended. A full technically exhaustive servicing is recommended for optimum efficiency. We recommend the heating and cooling systems be serviced on an annual basis.

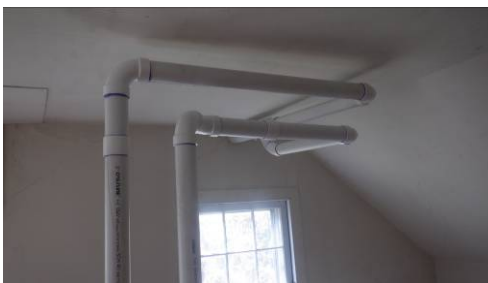
- **Action required:** Properly securing the 2<sup>nd</sup> zone heating system exhaust flue with hangers is necessary for safety. Contact a qualified HVAC technician to make a further evaluation and the necessary modifications.
