# Building Inspection Report

123 Sample Street Sample Town, NJ 12345

04/04/2022

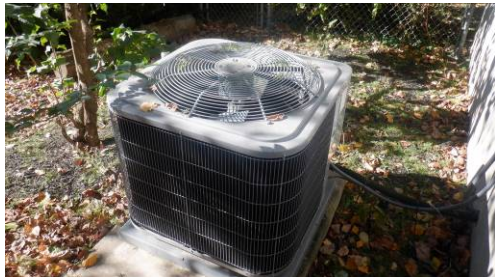
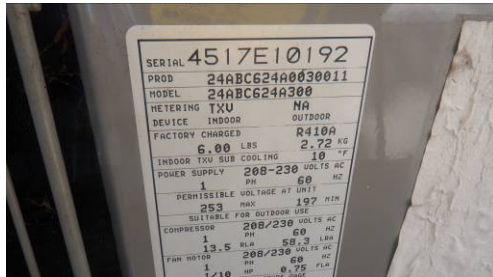
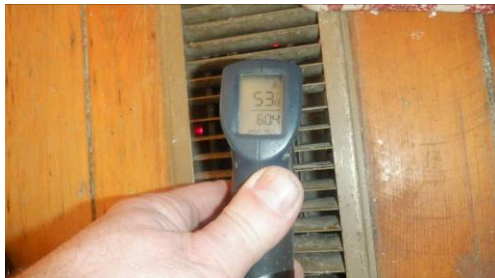
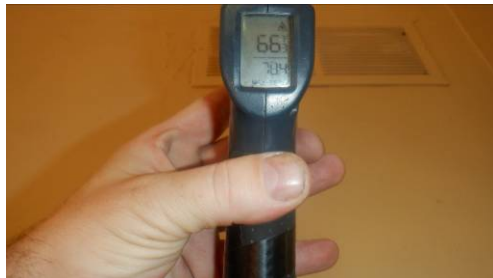
- **Attention:** The air conditioning unit was tested and was establishing proper degree ranges (between 12-20 degrees) at the supply and return vents. A full technically exhaustive servicing prior to the next cooling season is recommended for optimum efficiency. We recommend the heating and cooling systems be serviced on an annual basis.

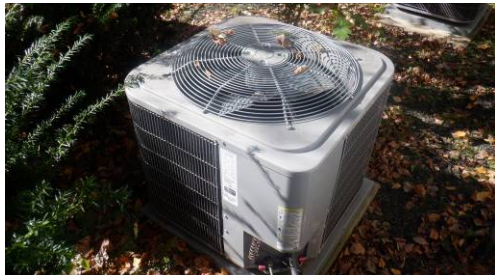
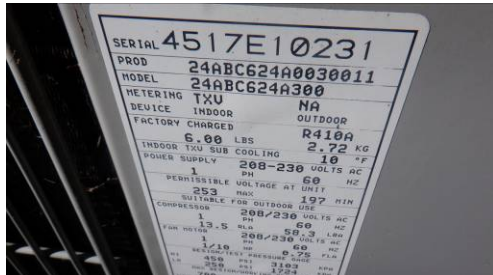
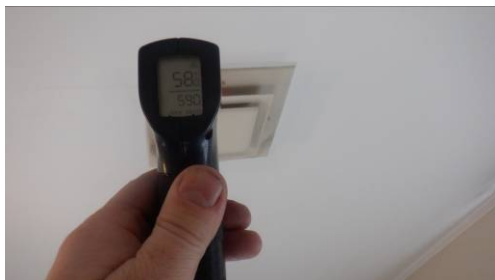
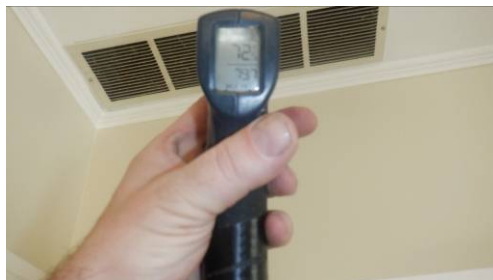
- **Attention:** The 2<sup>nd</sup> zone air conditioning unit was tested and was establishing proper degree ranges (between 12-20 degrees) at the supply and return vents. A full technically exhaustive servicing prior to the next cooling season is recommended for optimum efficiency. We recommend the heating and cooling systems be serviced on an annual basis.

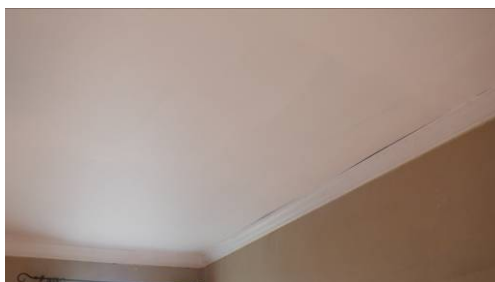
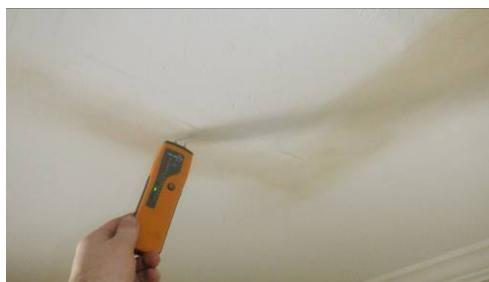
- The water was left running for approximately 15 minutes and the toilets were flushed at least 4-5 times at the time of the inspection. A program of regular inspection by the homeowner should be considered in order to identify any visible leaks prior to causing any substantial damage.
- Questioning the seller regarding any past leaks and repairs is recommended. Past leaks were noted under the upper hall bathroom but tested DRY at the time of the inspection.

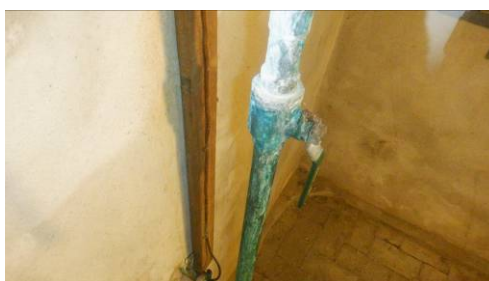
- It is recommended to insulate the supply water pipes in the crawl space areas to prevent possible damage during cold weather.

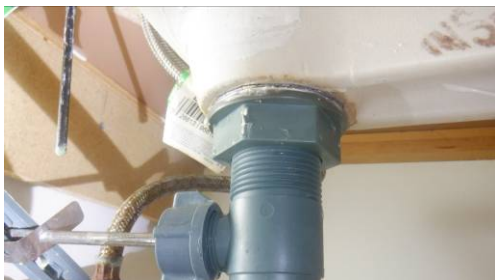
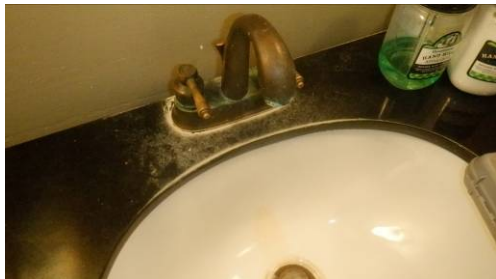
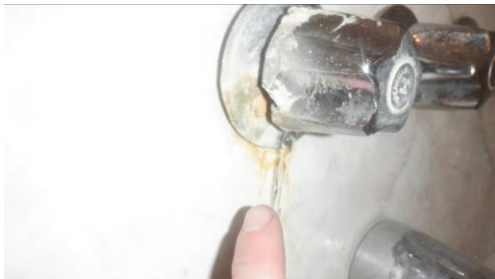
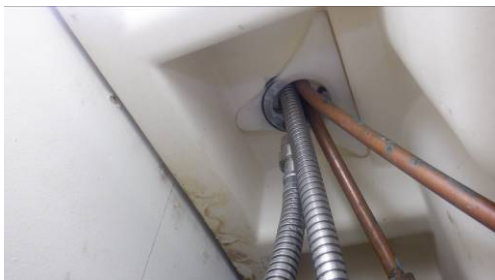
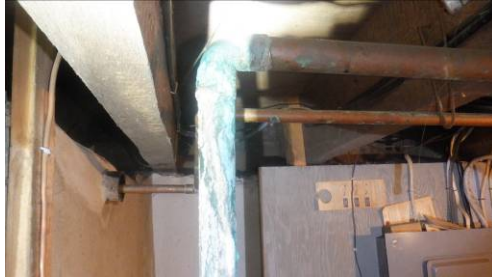
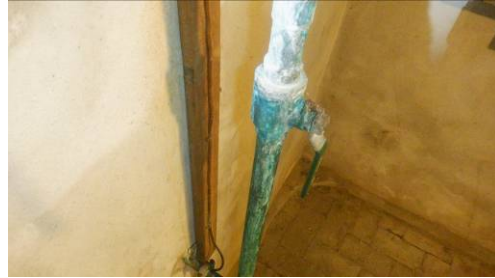
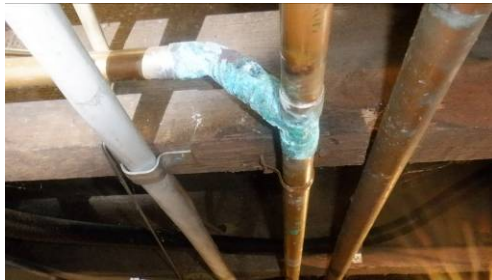
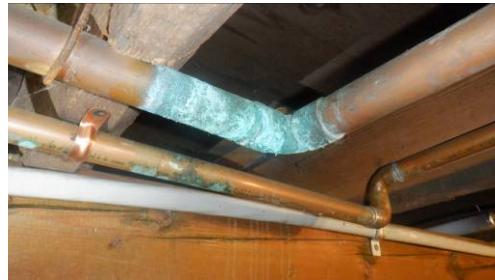
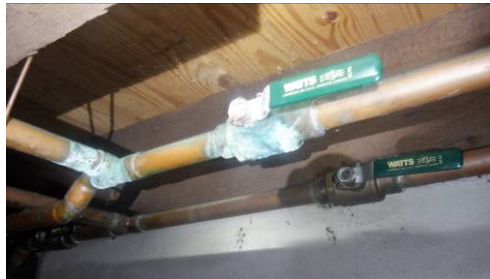
• **Action required:** An inspection of the readily accessible sections of the plumbing water supply, waste pipes, faucets and fixtures identified visible leak (s) that require repair at this time. The water was left running for approximately 10 minutes and the toilets were flushed at least 4 times at the time of the inspection. The inspector discovered current leaking at the right side master bathroom sink drain connection, right side master bathroom sink supply connection, the lower bathroom shower diverters, the lower bathroom sink drain connection, the kitchen sink diverter supply connections, The wet bar supply connections, the main copper supply connections in the basement, and several copper supply lines in the basement. In addition, the lower bathroom sink was dripping continuously in the OFF position. Repairs are recommended to prevent further deterioration and subsequent damage. Contact a licensed plumber to make a FULL technically exhaustive evaluation and the necessary repairs prior to transfer of ownership.

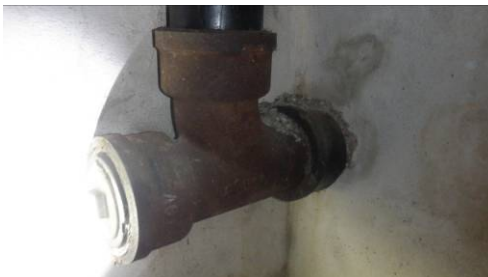
- **Attention:** The inspector recommends questioning the seller to determine the extent of the updates to the original sewer drain pipe from the house to the city sewer main. The sewer main line appears to be Cast Iron. Cast Iron piping typically has a serviceable life of 50 years and up. This inspection does not cover failure to sewer lines due to their inaccessibility to inspection. Periodic clearing of cast iron drain piping is often needed due to debris becoming stuck to the rough inside of the piping. Having the main sewer line from the house to the street professionally scoped with a camera is also strongly recommended as defects may exist.

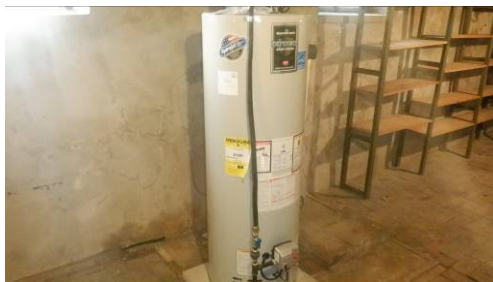
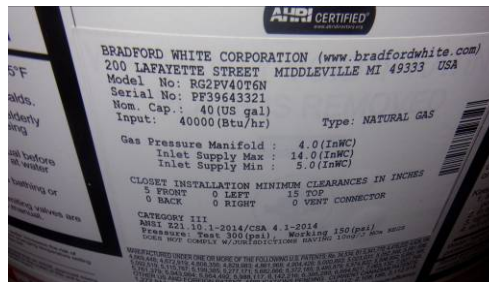
- Gas water heaters must have a continuous source of air and fuel. Items should not be stored against the water heater. Providing at least two feet of clearance around the water heater is recommended. Water heaters should also be drained periodically and serviced at the same time as the heating system. This will enable a service technician to give an indication on when the unit should be planned for replacement.

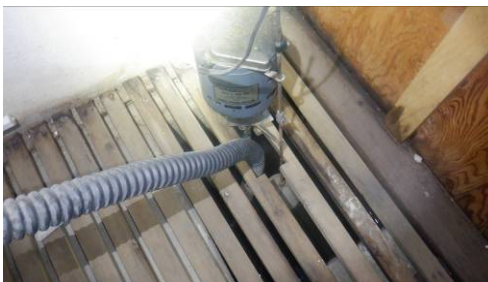
- There is a sump pump installed in the basement that appeared functional. Periodic inspection of the basement area during the winter is advisable to identify if the sump pump is providing the intended service. In addition, inspecting the sump pump every year prior to the fall for proper operation is recommended. Installing a check valve is also strongly recommended.

- **Action required:** The sump pump is currently draining directly into the sewer line. This may not be acceptable according to local ordinances. Extending the sump pump drain to the exterior should be considered. Verifying this during the certificate of occupancy inspection is recommended.

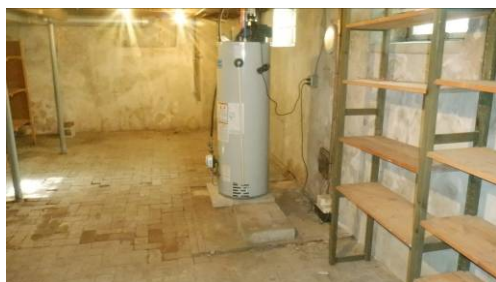
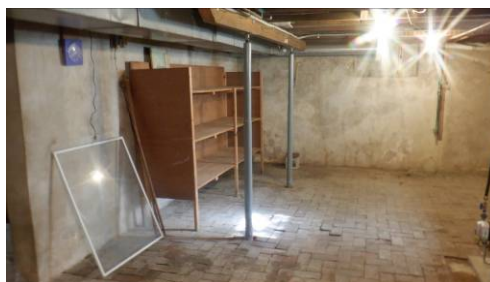
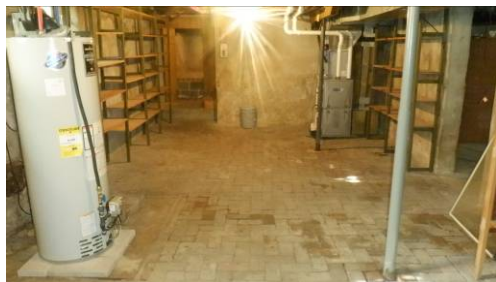
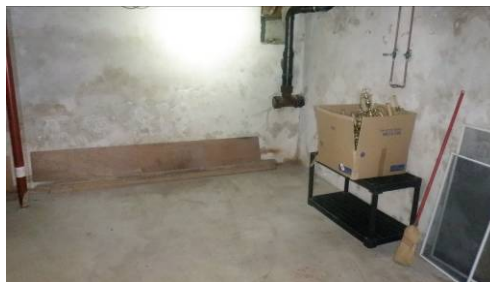
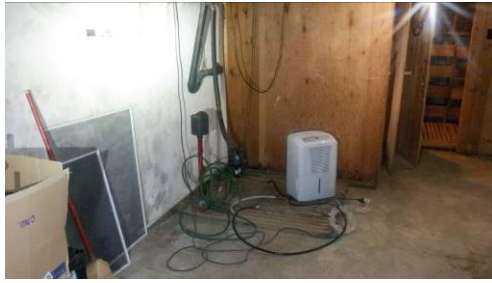
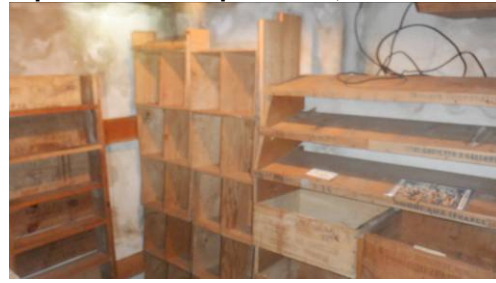
- **Action required:** There was visible deflection evident in the basement main beam and several of the floor joists. The main beam has been improperly notched and a significant amount of powder post beetle damage was noted. The deflection appeared to be carried to the floors above. The beam/joists appear to be in need of additional support. Contacting an individual qualified in structural repair or a licensed structural engineer is recommended for further evaluation and recommendations for repairs.

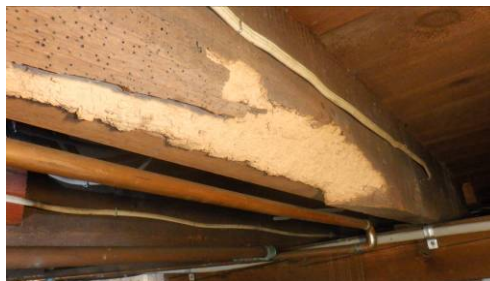
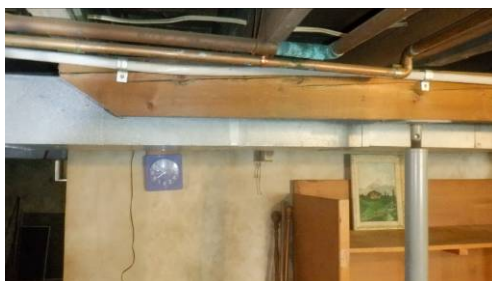
- **Action required:** There have been several temporary screw jack columns added in the basement that are not on any footings and are sitting on top of the floor slab, which is not designed to hold the weight. Footings are necessary to properly support the weight from above. In addition, the plates were not properly secured to girders with bolts. Furthermore, these columns are for temporary use not permanent use. It should also be noted that the columns were not properly installing at the end barring which is causing additional sagging. Contact a licensed structural engineer to make a further evaluation and the necessary repairs to ensure proper structural support.

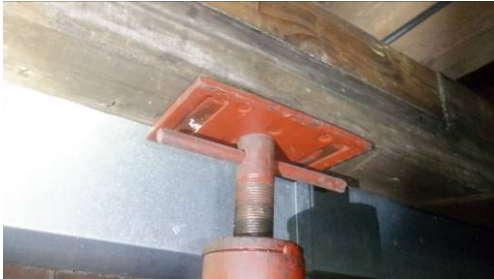
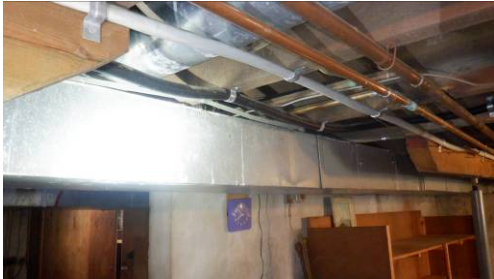
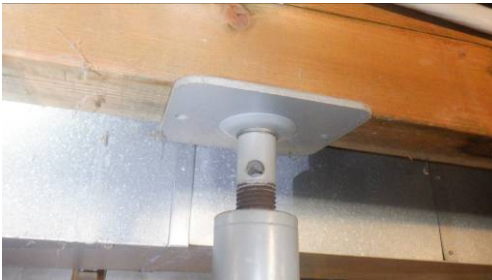
- **Action required:** The inspector discovered excessive powder post beetle and termite damage/activity in the basement. A full wood destroying insect infestation inspection is recommended to determine the need for treatment and/or repair. There may be areas of hidden damage not visible due to the non-invasive nature of this inspection.

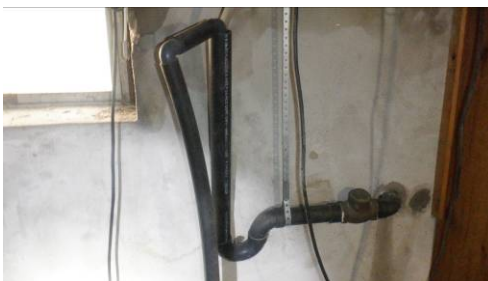
- **Action required:** There is evidence of minor present moisture penetration through the basement foundation walls. This was confirmed with a moisture meter. Exterior grade corrections, downspout extensions, the use of dehumidifiers, and waterproof paint coatings at the interior walls are recommended to reduce the amount of water penetration. Consulting with a qualified waterproofing company should be considered prior to transfer of ownership.

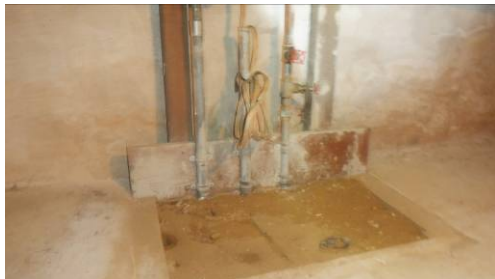
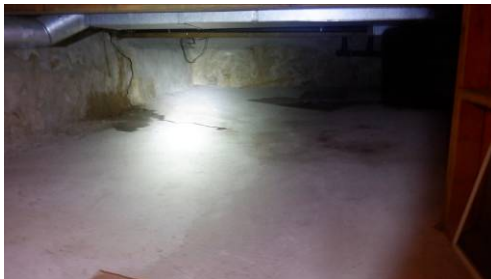
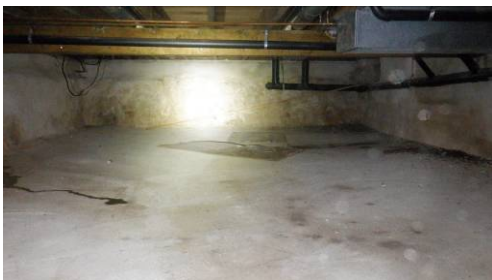
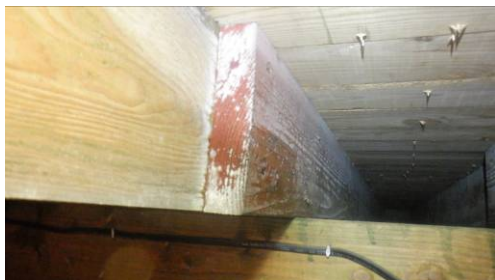
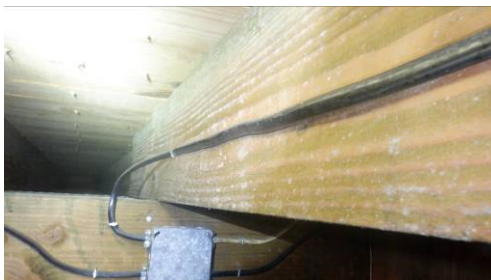
- **Action required:** Crawl spaces should be properly vented to reduce moisture levels. There was currently moisture intrusion and possible development of mold in the crawl space at the time of the inspection. Action should be taken to create better ventilation or dehumidification for the crawl space area to reduce the excessive moisture levels. Cleaning the areas with possible development of mold is also recommended to prevent a possible allergic reaction. A further evaluation by a qualified contractor is recommended prior to transfer of ownership.

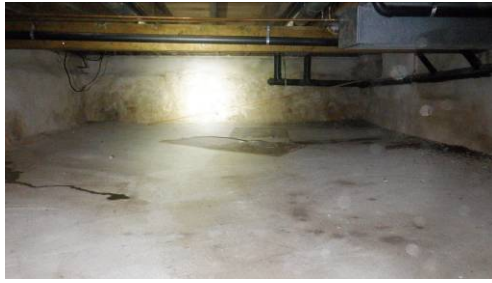
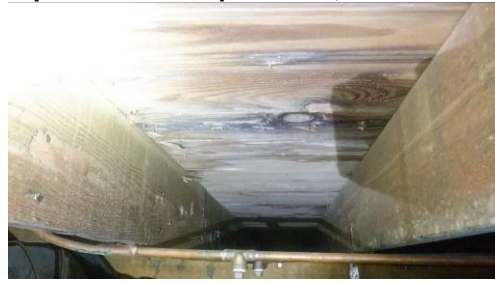
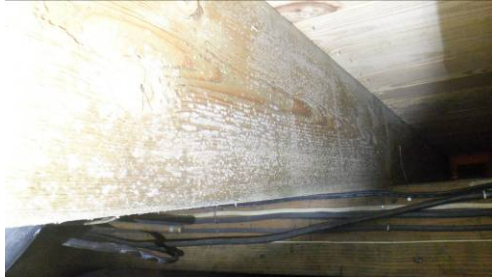
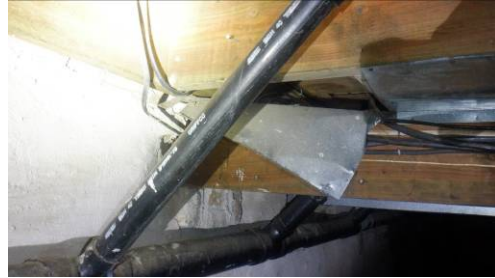
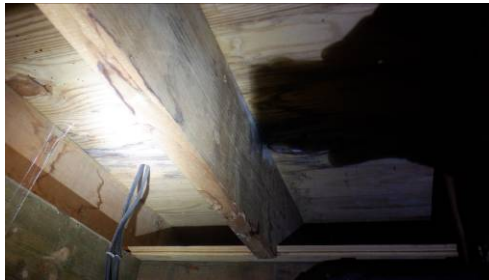
- **Attention:** There is no insulation in the crawl space. Consideration should be given to installing insulation between the crawl space and the first floor to increase heating efficiency.
